AIRPROX REPORT No 2025041

Date: 26 Mar 2025 Time: 1049Z Position: 5417N 00131W Location: RAF Leeming

PART A: SUMMARY OF INFORMATION REPORTED TO UKAB

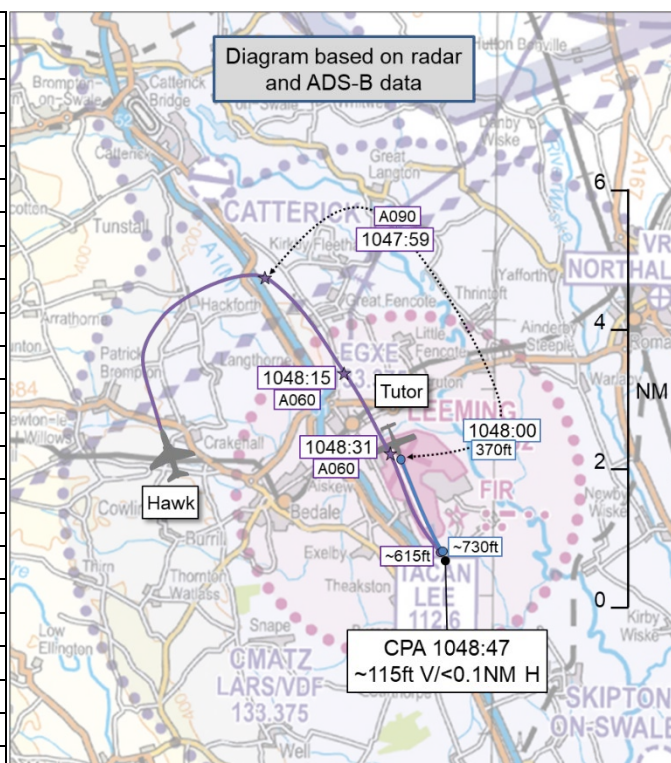
Recorded	Aircraft 1	Aircraft 2
Aircraft	Tutor	Hawk
Operator	HQ Air (Trg)	HQ Air (Trg)
Airspace	Leeming ATZ	Leeming ATZ
Class	G	G
Rules	VFR	VFR
Service	ACS	ACS
Provider	Leeming Tower	Leeming Tower
Altitude/FL	~730ft	~615ft
Transponder	A, C, S	A, C, S
Reported		
Colours	White with blue trim	Black
Lighting	HISL nav, landing	HISL & anti-colls
Conditions	VMC	VMC
Visibility	>10km	>10km
Altitude/FL	500ft	500ft
Altimeter	QFE (1016hPa)	NK
Heading	156°	156°
Speed	100kt	NR
ACAS/TAS	TAS	TCAS I
Alert	None	TA
Separation at CPA		
Reported	0ft V/0.2NM H	1500ft V/NR H
Recorded	~115ft V/<0.1NM H
