AIRPROX REPORT No 2025044

Date: 05 Apr 2025 Time: 1507Z Position: 5158N 00312W Location: Talgarth

PART A: SUMMARY OF INFORMATION REPORTED TO UKAB

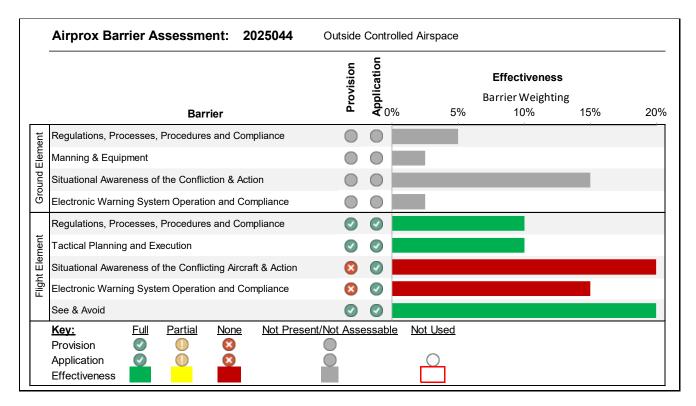
Situational Awareness of the Conflicting Aircraft and Action were assessed as **ineffective** because the ASK13 pilot had no situational awareness of the presence of the P68 and the P68 pilot had only generic situational awareness of the presence of gliders in the area.

Electronic Warning System Operation and Compliance were assessed as **ineffective** because the equipment carried by both aircraft had been incapable of receiving electronic emissions from the other.
