**AIRPROX REPORT No 2025047**

Date: 08 Apr 2025 Time: 0947Z Position: 5219N 00018W Location: IVO Grafham Water

**PART A: SUMMARY OF INFORMATION REPORTED TO UKAB**

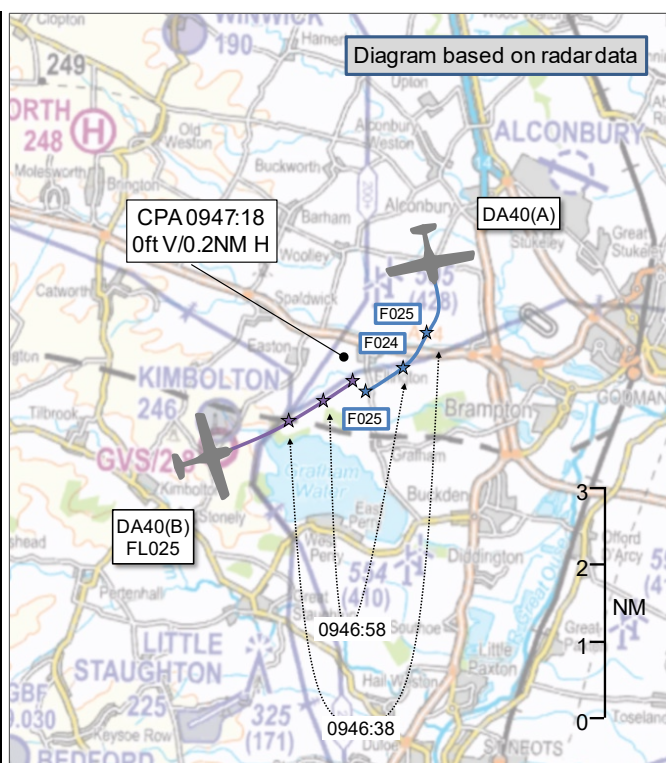
Recorded	Aircraft 1	Aircraft 2
Aircraft	DA40(A)	DA40(B)
Operator	Civ FW	Civ FW
Airspace	London FIR	London FIR
Class	G	G
Rules	VFR	VFR
Service	Basic	None <sup>1</sup>
Provider	Cranfield	N/A
Altitude/FL	FL025	FL025
Transponder	A, C, S+	A, C, S+
Reported		
Colours	White	White
Lighting	Nav, Strobes, Landing	Landing, Taxy, Nav, Strobes
Conditions	VMC	VMC
Visibility	>10km	>10km
Altitude/FL	2500ft	2900ft
Altimeter	QNH (1028hPa)	QNH (1028hPa)
Heading	240°	Northeast
Speed	120kt	110kt
ACAS/TAS	TAS	TAS
Alert	Information	Information
Separation at CPA		
Reported	100ft V/0.3NM H	NK V/>1NM H
Recorded	0ft V/0.2NM H
