AIRPROX REPORT No 2025050

Date: 11 Apr 2025 Time: 1316Z Position: 5346N 00301W Location: Blackpool Airport.

An Airprox was reported when a C152 and a C172 flew into proximity on the approach to Blackpool Airport at 1316Z on Friday 11th April 2025. Both pilots were operating under VFR in VMC within the Blackpool ATZ and in receipt of an ACS from Blackpool Tower.

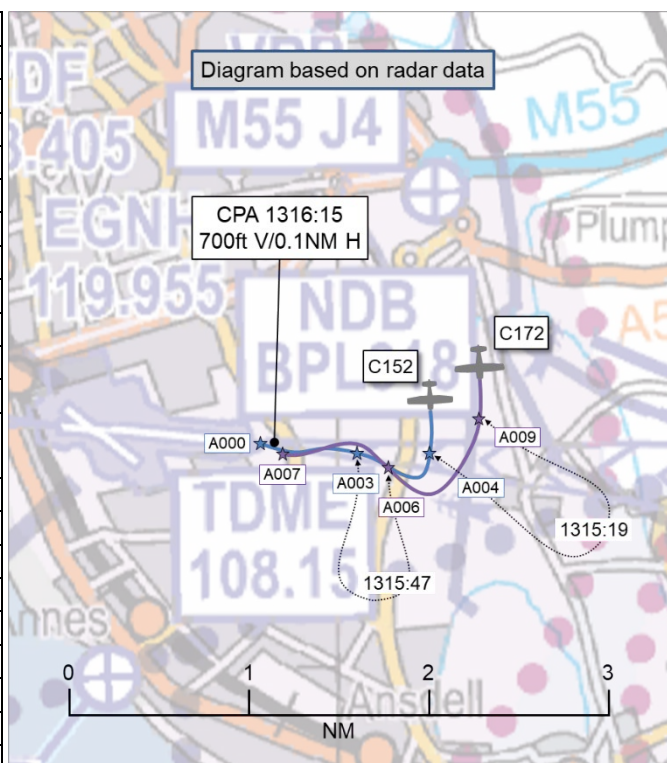
THE C152 PILOT reports that they received instructions from ATC to report east abeam Blackpool's Tall Tower VRP. They reported there when they arrived at said point, at which point [the C172] also reported east abeam the Tall Tower VRP stating they *"had this microlight to my left"* (referring to their C152). The [C172 pilot] was given instructions to position behind them and that they were number 3 for arrival. At this point [the C172 pilot] said *"roger, I'm actually overtaking the aircraft"*. At this point [the C152 pilot] actually wasn't that concerned of any collision happening as [the C172 pilot] had contact with them and they could see [the C172]. At this point they assumed the [C172 pilot] would slow their aircraft down to position behind [the C152] as requested. The C152 [pilot] was given number 2 behind [another aircraft] on final and to report final. When they reported final, [the C172 pilot] reported final straight after them stating *"I'm going to have to go around, I'm on top of this aircraft in front of me"*. ATC then reiterated to them that they were told to position behind [the C152]. [The C172 pilot] was given a left-hand circuit to land on RW28.

THE C172 PILOT reports that they had previously reported to Blackpool ATC that they were overhead Poulton VRP at 2000ft and requested a rejoin. They were given the QFE and told to report east of the Tall Tower VRP and to expect a right base for RW28. They commenced a slow descent on a heading of 185° and, upon reaching the point east of the Tall Tower, were just about to report their position when a small aircraft rose from below them, approximately 1NM ahead and 30° to their left. (They commented to their student *'where has he come from'* since they had heard no call from another aircraft nor had ATC advised them that there was another aircraft in a similar position). They called ATC, advising east of the Tall Tower and that there was a small aircraft that had risen from below just ahead of them. ATC asked if that was a Cessna which they confirmed. They were instructed to position number 3 behind the Cessna which was number 2. By this time they were already almost abeam the [C152]. They replied that they would [position behind the C152] but that the [C152] was travelling much slower than them.

ATC instructed them to report right base. They immediately powered down with the intention of getting behind the [C152] and undertaking a left-hand orbit to give additional separation. The [C152], however, started to veer left so they maintained their heading to keep it in sight and assess [the pilot's] intentions. The [C152] then started to descend and turn right on a course to pass under them. They climbed, to further increase vertical separation, and turned eastward with the intention of adopting a wide right-base position. By this time they had crossed the M55 and they reported wide right-base. ATC asked if they had the [C152] in sight which they confirmed. ATC instructed them to report 'final'. They maintained eye contact with the [C152] but at no time heard any calls from it for either right-base or final, and at this point they were wondering if the [C152] had a transmit problem. They heard ATC give a clearance to an aircraft [unknown c/s] for a 'touch and go' which they assumed to be the [C152] and they could see [the C152] was turning on a short final. They reported that they were turning final but maintained an altitude of 700ft and then called that they were going around and began climbing. They watched the [C152] land and heard them say "[C/S] was too close" which confirmed they did not have a transmit problem. They completed a left-hand circuit as instructed by ATC and landed. At no time did they lose visual contact with the [C152] from when they rose into view ahead of them, other than briefly when they passed below them left-to-right. Also, at no time did they hear [the C152 pilot] make any calls other than the comment upon landing that "[C/S] was too close".
