**AIRPROX REPORT No 2025054**

Date: 18 Apr 2025 Time: 1222Z Position: 5354N 00046W Location: 1.5NM south of Pocklington

**PART A: SUMMARY OF INFORMATION REPORTED TO UKAB**

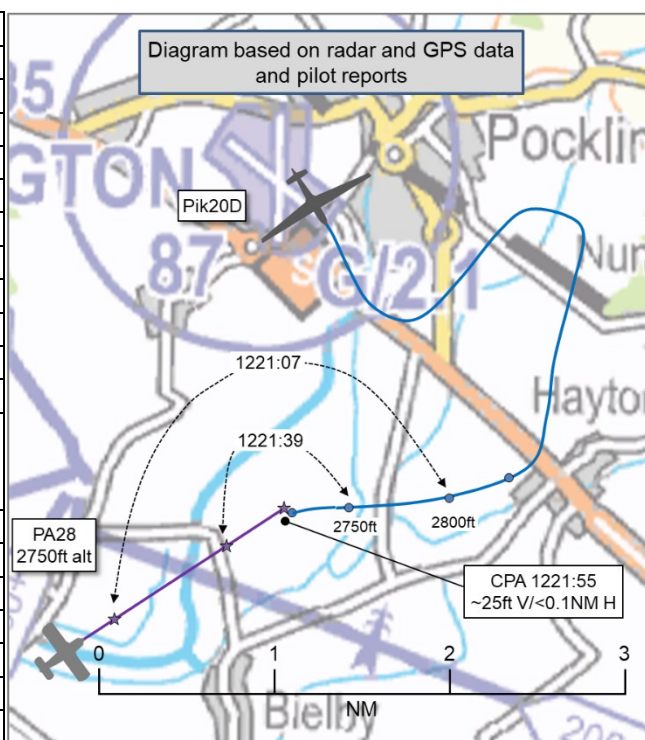
Recorded	Aircraft 1	Aircraft 2
Aircraft	Pik20D	PA28
Operator	Civ Gld	Civ FW
Airspace	London FIR	London FIR
Class	G	G
Rules	VFR	VFR
Service	None	Establishing contact
Provider	N/A	H'side Approach
Altitude/FL	~2775ft	2750ft
Transponder	Not fitted	A, C, S
Reported		
Colours	White	White, yellow, blue
Lighting	None	Landing, taxi, nav, anti-colls, strobes, beacon
Conditions	VMC	VMC
Visibility	>10km	>10km
Altitude/FL	2700ft	3000ft
Altimeter	QFE (1011hPa)	QNH
Heading	270°	090°
Speed	55kt	100kt
ACAS/TAS	FLARM	Not fitted
Alert	Information	N/A
Separation at CPA		
Reported	<10ft V/100m H	NR
Recorded	~25ft V/<0.1NM H
