AIRPROX REPORT No 2025063

Date: 29 Apr 2025 Time: 1335Z Position: 5319N 00056W Location: Retford/Gamston ATZ

PART A: SUMMARY OF INFORMATION REPORTED TO UKAB

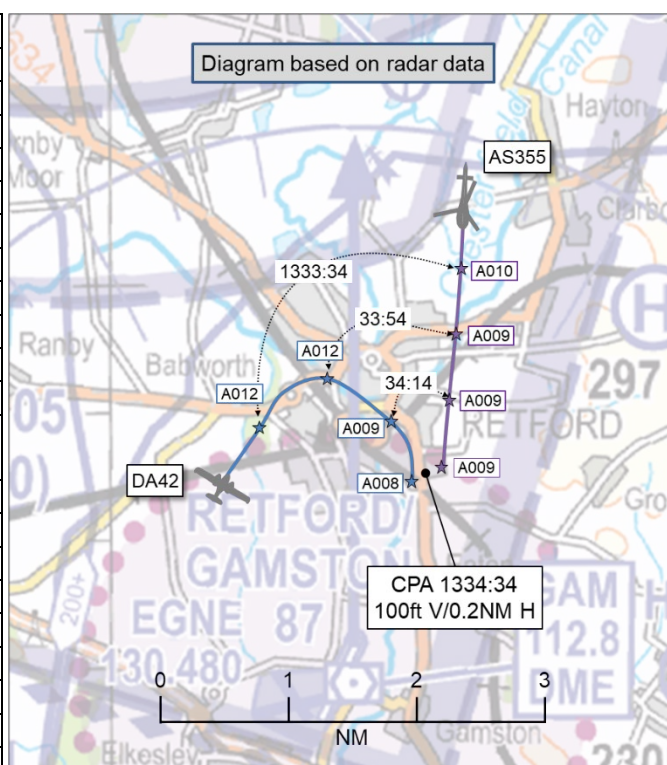
Recorded	Aircraft 1	Aircraft 2
Aircraft	DA42	AS355
Operator	Civ FW	Civ Comm
Airspace	Gamston ATZ	Gamston ATZ
Class	G	G
Rules	VFR	VFR
Service	AGCS	AGCS
Provider	Gamston Radio	Gamston Radio
Altitude/FL	800ft	900ft
Transponder	A, C, S+	A, C, S
Reported		
Colours	White	Grey
Lighting	Anti-colls, nav, landing and taxi	Anti-colls & nav.
Conditions	VMC	VMC
Visibility	>10km	>10km
Altitude/FL	600ft	900ft
Altimeter	QNH (1026hPa)	QNH (1026hPa)
Heading	NK	020°
Speed	95kt	90kt
ACAS/TAS	TAS	SkyEcho
Alert	Alert	Information
Separation at CPA		
Reported	0ft V/200m H	0ft V/100m H
Recorded	100ft V/0.2NM H

When reaching the end of their base leg (approximately 5sec before initiating a turn onto final), an aural TAS warning was heard and illustrated an aircraft at the same level (600ft AMSL), extremely close to themselves. They had previously checked the final approach track and nothing was seen, and their primary focus was on the aircraft (now on short final) to ensure separation. At this point, a rotary aircraft [pilot] had called final and they were visual with one ahead, no previous radio calls were heard from the rotary aircraft. They and another crew member in the back of the aircraft then became visual with the rotary aircraft, approximately 200m away in their 10 o'clock. Once visual with the rotary aircraft, they performed avoiding action by applying maximum power and initiating a [best angle of] climb. No avoiding action was visually noted from the rotary aircraft. After this, they continued the climb into the
