**AIRPROX REPORT No 2025073**

Date: 02 May 2025 Time: 1644Z Position: 5416N 00118W Location: 0.5NM NNW of Felixkirk

**PART A: SUMMARY OF INFORMATION REPORTED TO UKAB**

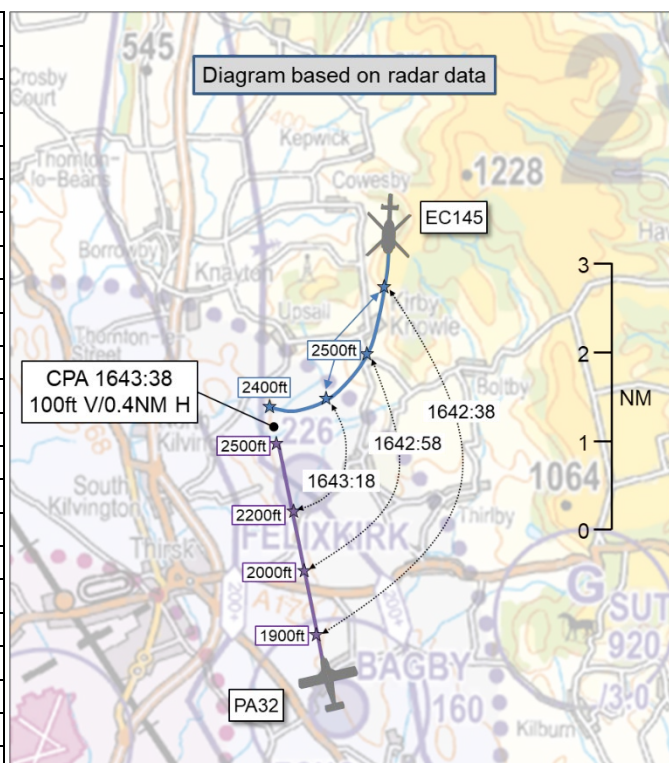
| Recorded | Aircraft 1 | Aircraft 2 |
|---|---|---|
| Reported | 50ft V/0.5NM H | 100ft V/1NM H |
| Recorded | 100ft V/0.4NM H | |
