**AIRPROX REPORT No 2025082**

Date: 09 May 2025 Time: 1322Z Position: 5319N 00144W Location: IVO Camphill

**PART A: SUMMARY OF INFORMATION REPORTED TO UKAB**

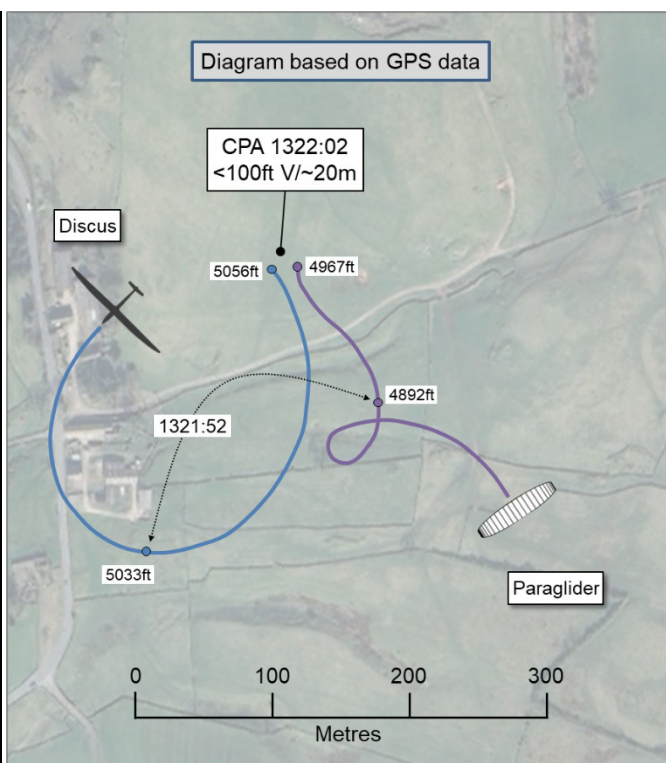
An analysis of the NATS radar replay was undertaken. Neither aircraft was observed on the replay. Both pilots kindly supplied GPS track data for their respective flights (Figure 1).

Members noted that the diameter of the circles described by each aircraft had been significantly different, as had their respective centres of rotation. That is, the aircraft had not described concentric circles around a common point. To further complicate the geometry, the circles of the paraglider had been beneath those of the Discus (with reducing horizontal separation) and both pilots had been climbing (with the paraglider pilot climbing at a faster rate). Additionally, both pilots had been drifting north-westwards to follow the thermal lift.
