**AIRPROX REPORT No 2025090**

Date: 08 May 2025 Time: 1501Z Position: 5357N 00034W Location: 4NM S Wetwang

**PART A: SUMMARY OF INFORMATION REPORTED TO UKAB**

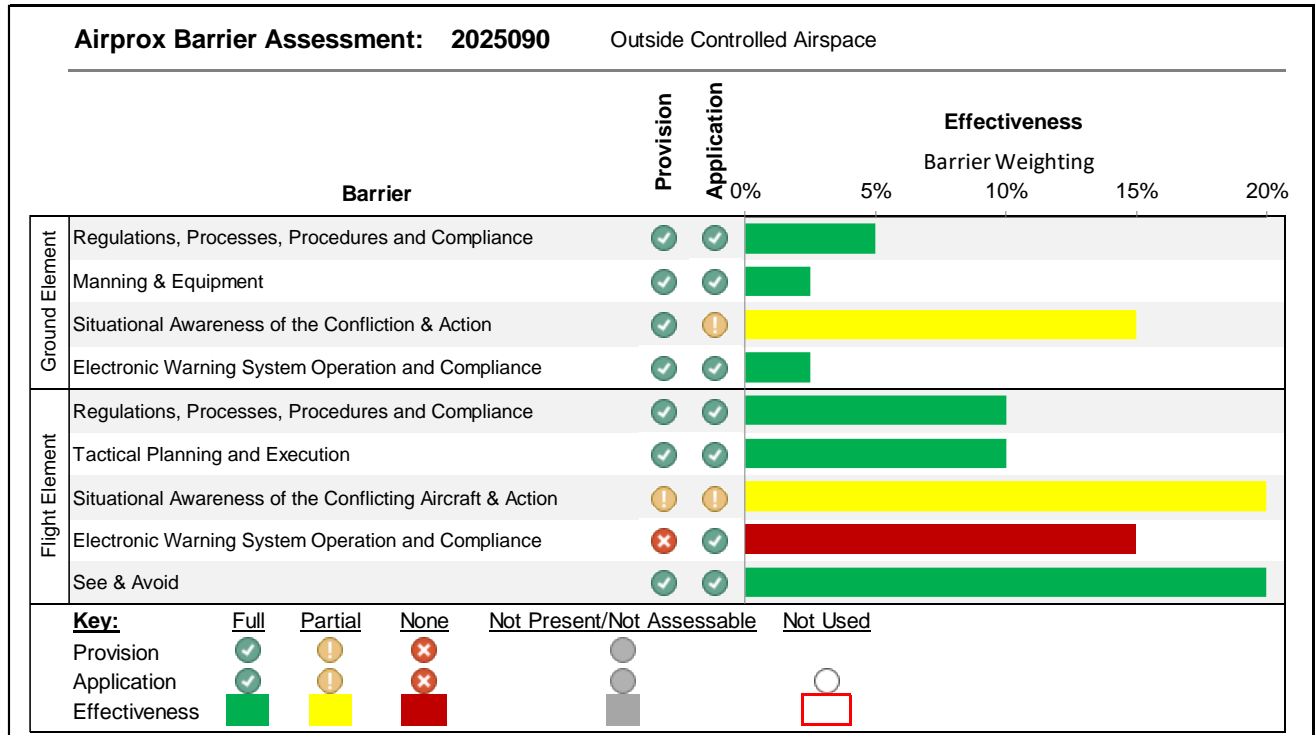
**Situational Awareness of the Conflicting Aircraft and Action** were assessed as **partially effective** because the Typhoon pilot's situational awareness of the L159 had not been updated and they had not requested an update.

**Electronic Warning System Operation and Compliance** were assessed as **ineffective** because the L159 TAS could not detect the Typhoon.
