**AIRPROX REPORT No 2025092**

Date: 20 May 2025 Time: 1412Z Position: 5155N 00150W Location: IVO Upper Harford

**PART A: SUMMARY OF INFORMATION REPORTED TO UKAB**

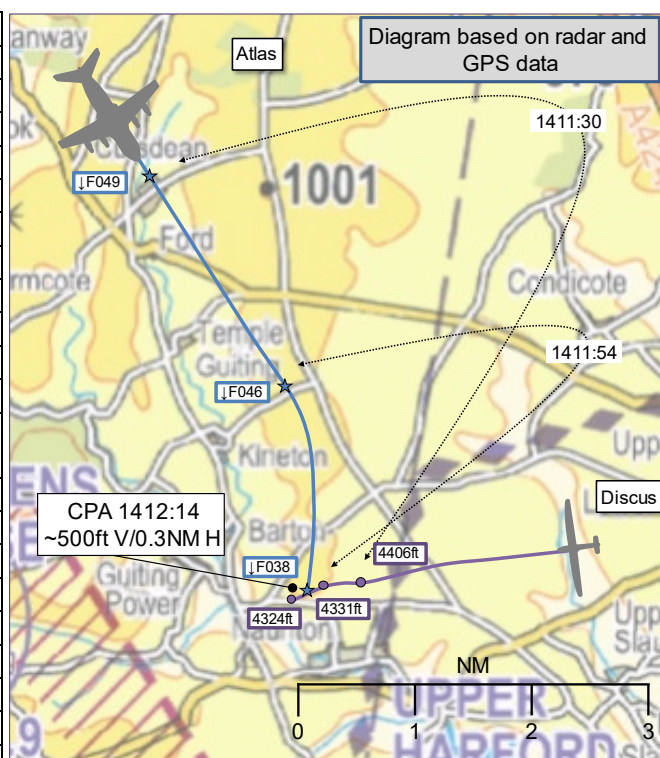
| Recorded | Aircraft 1 | Aircraft 2 |
|---|---|---|
| Reported | 300ft V/0m H | 500ft V/0m H |
| Recorded | ~500ft/0.3NM H | |
