**AIRPROX REPORT No 2025100**

Date: 25 May 2025 Time: 1203Z Position: 5109N 00017E Location: NE Tunbridge Wells

**PART A: SUMMARY OF INFORMATION REPORTED TO UKAB**

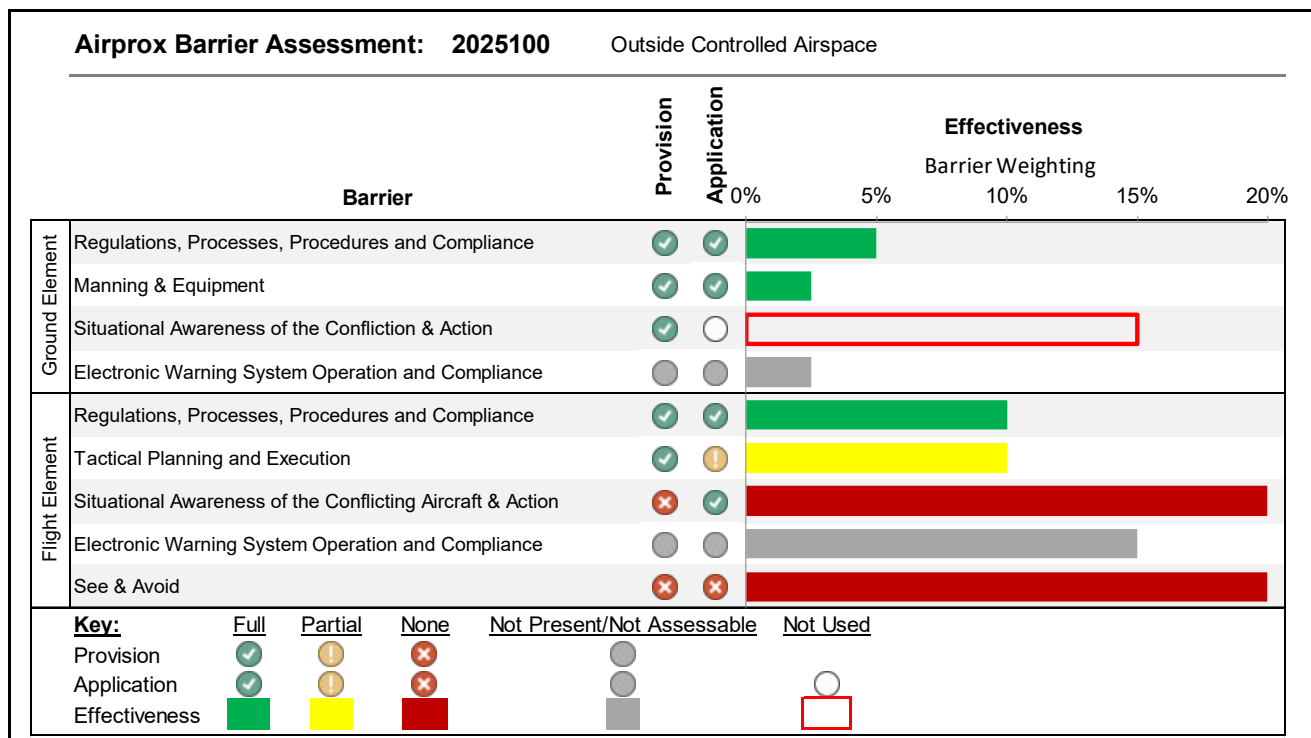
**Situational Awareness of the Conflicting Aircraft and Action** were assessed as **ineffective** because the pilot of PA28(A) had no situational awareness of the presence of PA28(B) and the pilot of PA28(B) had only generic situational awareness of the presence of and position of PA28(A) from the pilot's initial communication with Farnborough LARS.

**See and Avoid** were assessed as **ineffective** because the pilot of PA28(A) had not seen PA28(B) until the point of CPA and the pilot of PA28(B) had not seen PA28(A).
