AIRPROX REPORT No 2025105

Date: 23 May 2025 Time: 1549Z Position: 5145N 00057W Location: Thame

PART A: SUMMARY OF INFORMATION REPORTED TO UKAB

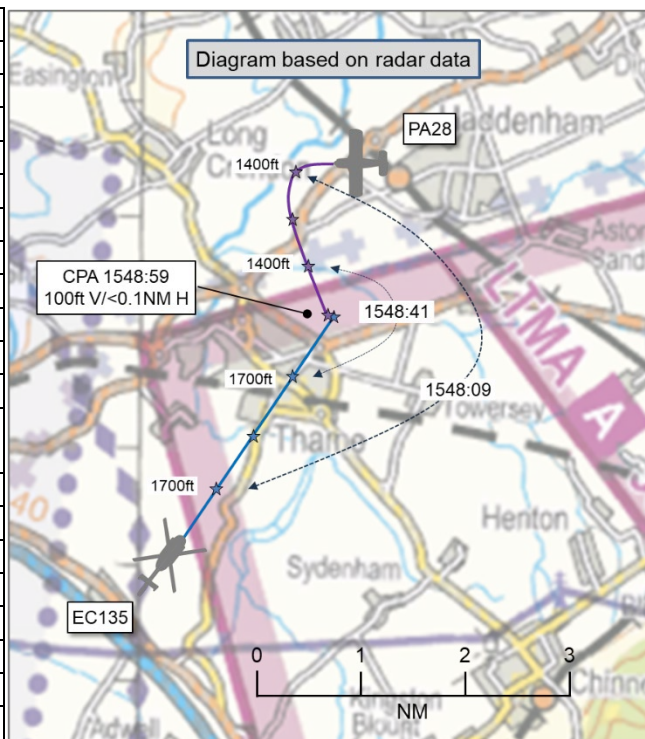
Recorded	Aircraft 1	Aircraft 2
Aircraft	EC135	PA28
Operator	HEMS	Civ FW
Airspace	London FIR	London FIR
Class	G	G
Rules	VFR	VFR
Service	Basic	Listening Out
Provider	Brize Norton	Farnboro' Radar
Altitude/FL	1800ft	1700ft
Transponder	A, C, S+	A, C, S
Reported		
Colours	Red	White, blue, yellow
Lighting	Navigation, strobes, skid LEDs	Landing
Conditions	VMC	VMC
Visibility	>10km	>10km
Altitude/FL	1500ft	1500ft
Altimeter	QNH	QNH (1018hPa)
Heading	027°	160°
Speed	130kt	95kt
ACAS/TAS	TAS	SkyEcho
Alert	TA	None
Separation at CPA		
Reported	100ft V/0NM H	50ft V/50m H
Recorded	100ft V/<0.1NM H
