**AIRPROX REPORT No 2025118**

Date: 20 Jun 2025 Time: 0943Z Position: 5145N 00121W Location: Farmoor Reservoir

**PART A: SUMMARY OF INFORMATION REPORTED TO UKAB**

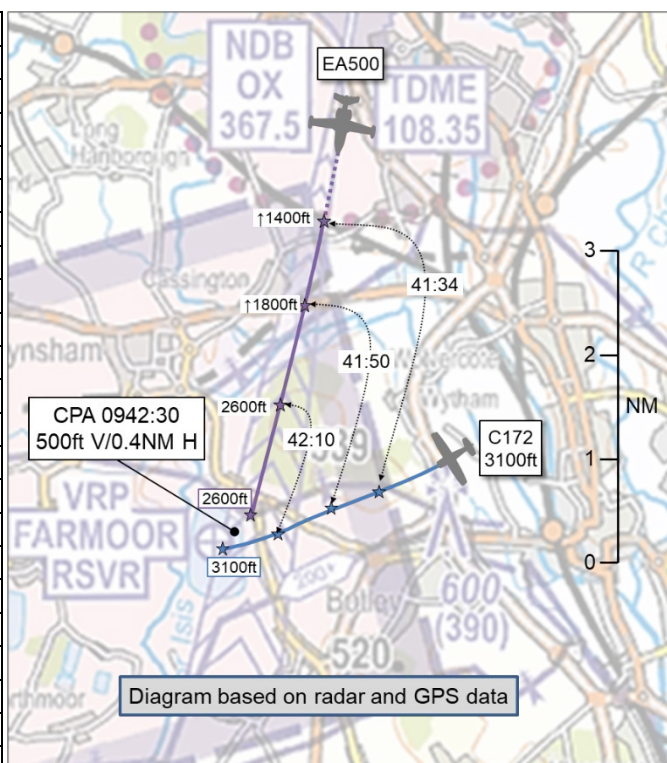
Recorded	Aircraft 1	Aircraft 2
Aircraft	C172	EA500
Operator	Civ FW	Civ Comm
Airspace	Brize Norton CTR	Brize Norton CTR
Class	D	D
Rules	VFR	IFR
Service	Radar Control	Radar Control
Provider	Brize Zone	Oxford Radar
Altitude	3100ft	2600ft
Transponder	A, C, S	A, C, S
<b>Reported</b>		
Colours	Beige	White/Orange
Lighting	Beacon & strobes	Stb, taxi/ldg, nav
Conditions	VMC	VMC
Visibility	>10km	>10km
Altitude/FL	3000ft	~1500ft climbing
Altimeter	QNH (1023hPa)	QNH
Heading	NK	190°
Speed	110kt	165kt
ACAS/TAS	SkyEcho	TCAS I
Alert	Information	Information
<b>Separation at CPA</b>		
Reported	600ft V/<500m H	300ft V/3m H
Recorded	500ft V/0.4NM H
