AIRPROX REPORT No 2025143

Date: 08 Jul 2025 Time: 1331Z Position: 5202N 00039W Location: ivo Cranfield

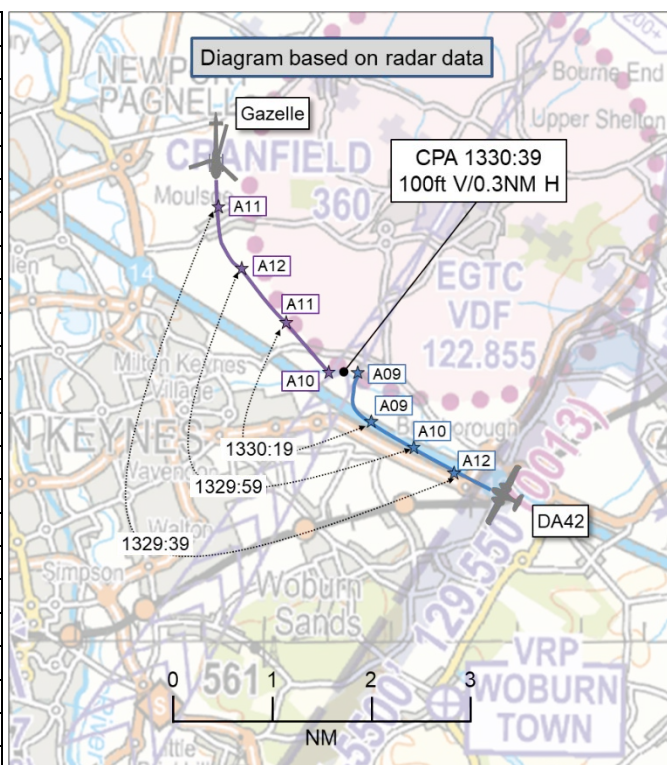
Recorded	Aircraft 1	Aircraft 2
Aircraft	DA42	Gazelle
Operator	Civ FW	Civ Helo
Airspace	Cranfield ATZ	London FIR
Class	G	G
Rules	VFR	VFR
Service	ACS	ACS
Provider	Cranfield Tower	Cranfield Tower
Altitude	900ft	1000ft
Transponder	A, C, S	A, C, S
Reported		
Colours	White	Red
Lighting	Strbs, nav,ldg,taxi	Tail & main strbs.
Conditions	VMC	VMC
Visibility	>10km	>10km
Altitude/FL	700ft	~200ft
Altimeter	QNH	QNH (1015hPa)
Heading	300°	090°
Speed	95kt	80kt
ACAS/TAS	Not fitted	SkyEcho
Alert	N/A	None
Separation at CPA		
Reported	0ft V/100m H	NK V/ 1NM H
Recorded	100ft V/0.3NM H
