AIRPROX REPORT No 2025147

Date: 28 Jun 2025 Time: 1538Z Position: 5214N 00100E Location: 3NM N Stowmarket

PART A: SUMMARY OF INFORMATION REPORTED TO UKAB

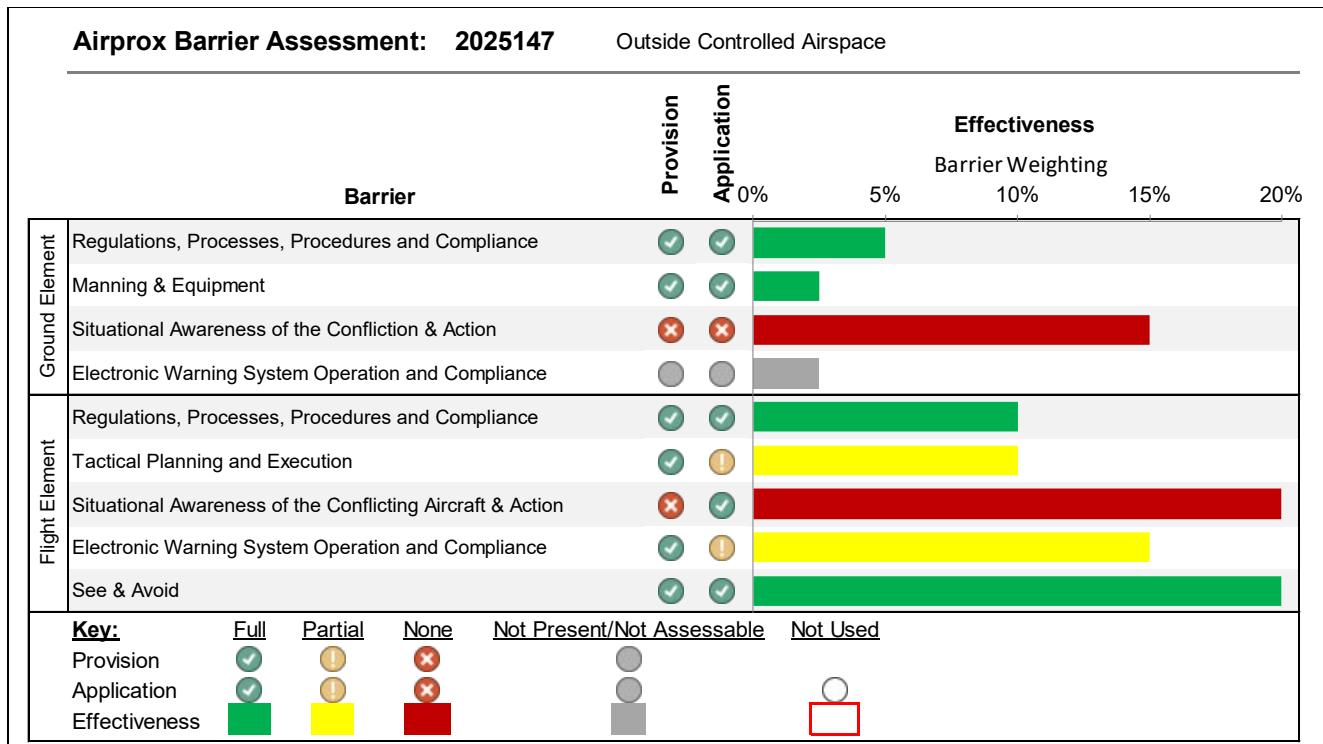
Situational Awareness of the Conflicting Aircraft and Action were assessed as **ineffective** because neither pilot had situational awareness of the presence of the other aircraft.

Electronic Warning System Operation and Compliance were assessed as **partially effective** because the TCAS equipment fitted to the KC135 had provided a Resolution Advisory later than would have been expected.
