AIRPROX REPORT No 2025149

Date: 17 Jul 2025 Time: ~1642Z Position: 5435N 00102W Location: Marske-by-the-Sea

PART A: SUMMARY OF INFORMATION REPORTED TO UKAB

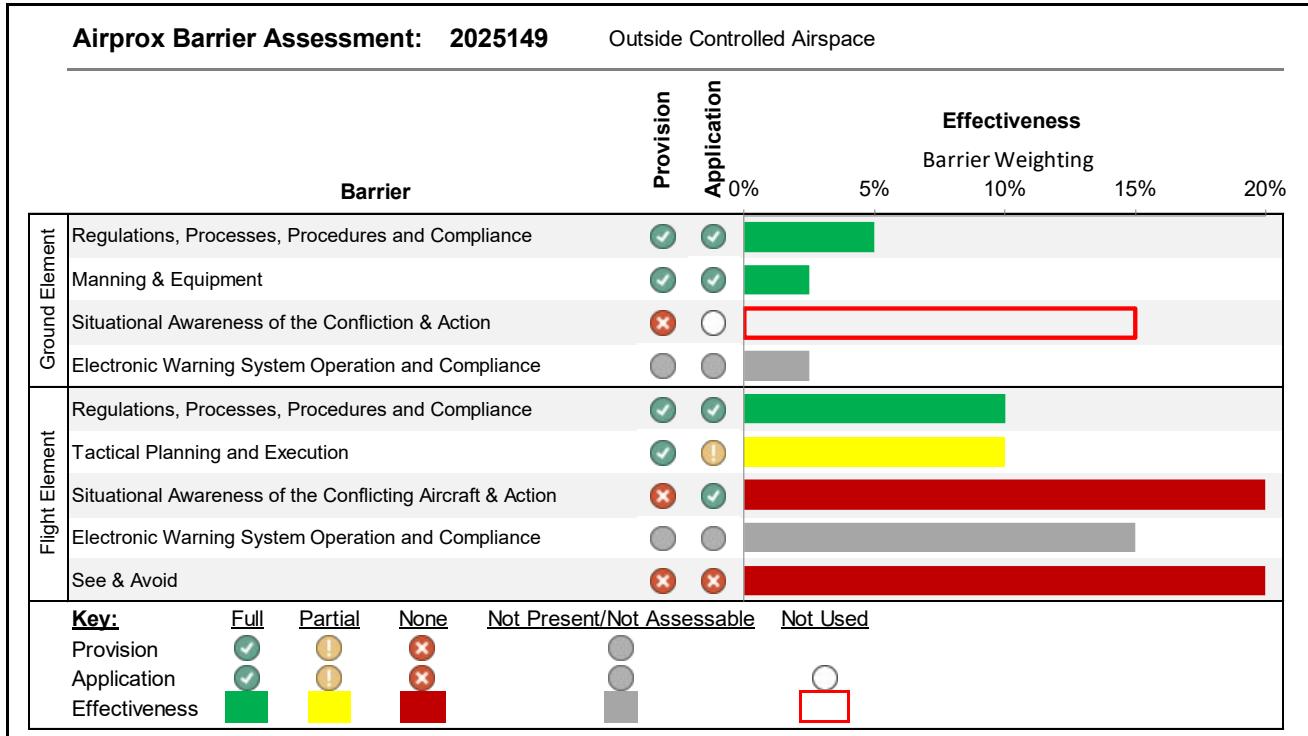
Situational Awareness of the Conflicting Aircraft and Action were assessed as **ineffective** because neither pilot knew that the other aircraft had been in the vicinity.

See and Avoid were assessed as **ineffective** because neither pilot had seen the other in time to take effective avoiding action.
