AIRPROX REPORT No 2025156

Date: 23 Jul 2025 Time: 1513Z Position: 5110N 00131W Location: 2.9NM NE of Middle Wallop

PART A: SUMMARY OF INFORMATION REPORTED TO UKAB

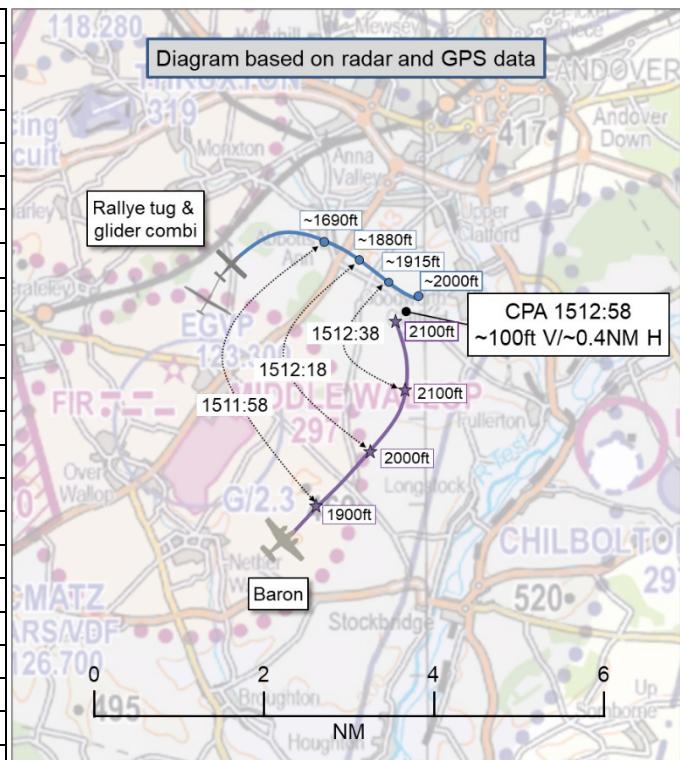
THE MIDDLE WALLOP AIR/GROUND OPERATOR reports that a glider was in free glide slightly above Middle Wallop ATZ, and a tug aircraft, [the Rallye], was towing another glider in a similar area but within the ATZ [they believe]. Without any radio contact, a Beech Baron flew through the ATZ at 2100ft travelling south-to-north, passing within 100ft-150ft from the glider in free flight and the tug with a glider on tow. There was a NOTAM active advising of a major gliding competition taking place at the time from Middle Wallop airfield.

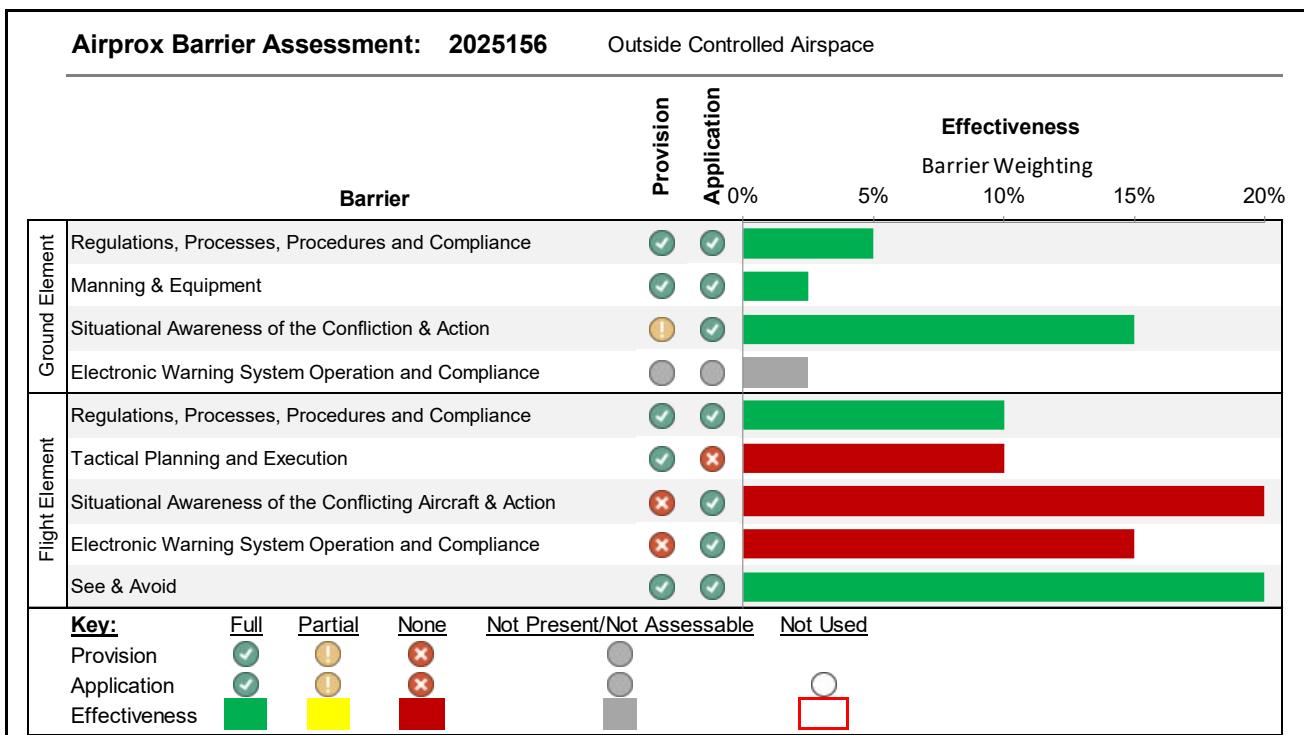
Situational Awareness of the Conflicting Aircraft and Action were assessed as **ineffective** because the Rallye pilot had no situational awareness of the presence of the Baron and the Baron pilot had only generic awareness of multiple gliders in the vicinity.

Electronic Warning System Operation and Compliance were assessed as **ineffective** because the electronic conspicuity equipment fitted in each aircraft had been incompatible and unable to detect the other aircraft.
