**AIRPROX REPORT No 2025162**

Date: 30 Jul 2025 Time: 1353Z Position: 5211N 00116W Location: 1NM NNW Byfield Daventry

**PART A: SUMMARY OF INFORMATION REPORTED TO UKAB**

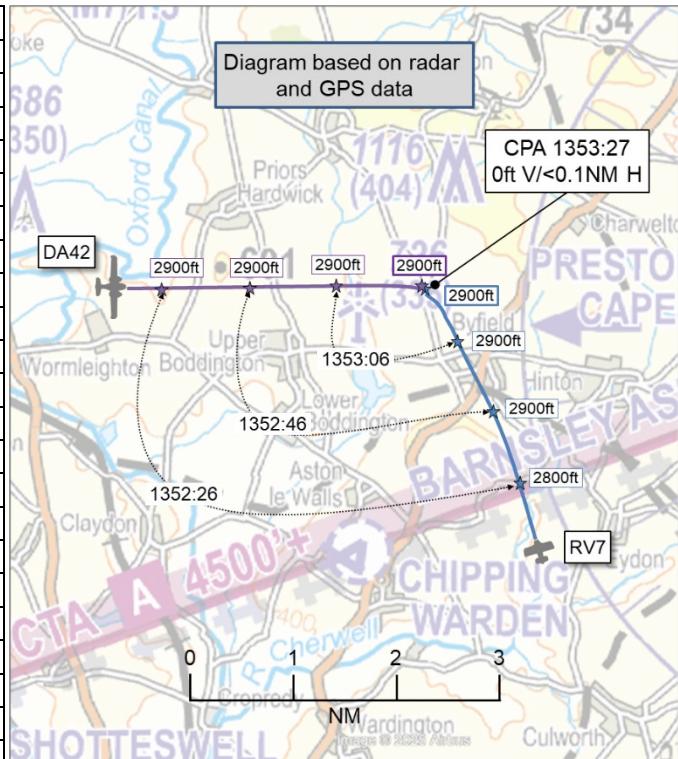
Recorded	Aircraft 1	Aircraft 2
Aircraft	RV7	DA42
Operator	Civ FW	Civ FW
Airspace	London FIR	London FIR
Class	G	G
Rules	VFR	VFR
Service	Basic	Basic
Provider	Birmingham Rdr	Wellesbourne Info
Altitude	2900ft	2900ft
Transponder	A, C, S	A, C, S
Reported		
Colours	White/Blue	White
Lighting	NR	Strobes, taxi, land
Conditions	VMC	VMC
Visibility	>10km	>10km
Altitude/FL	2900ft	3000ft
Altimeter	QNH (1019hPa)	QNH (1018hPa)
Heading	330°	092°
Speed	150kt	140kt
ACAS/TAS	SkyEcho	Not fitted
Alert	None	None
Separation at CPA		
Reported	100ft V/50m H	50ft V/500m H
Recorded	0ft V/<0.1NM H

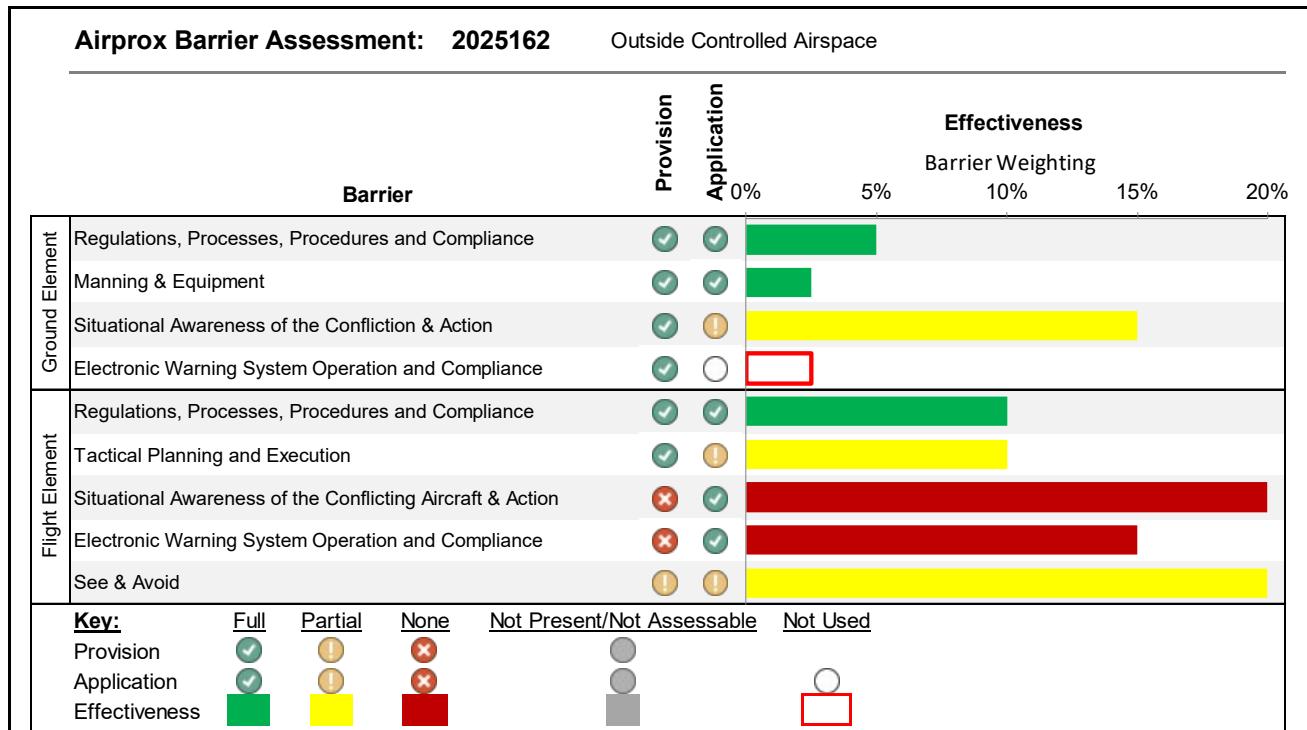
**Electronic Warning System Operation and Compliance** were assessed as **ineffective** because the electronic conspicuity equipment fitted in the RV7 could not detect the DA42.

**See and Avoid** were assessed as **partially effective** because both the RV7 and DA42 pilots had not seen the other aircraft until immediately prior to CPA.
