AIRPROX REPORT No 2025164

Date: 28 Jul 2025 Time: 1416Z Position: 5341N 00136W Location: Ossett, Wakefield

PART A: SUMMARY OF INFORMATION REPORTED TO UKAB

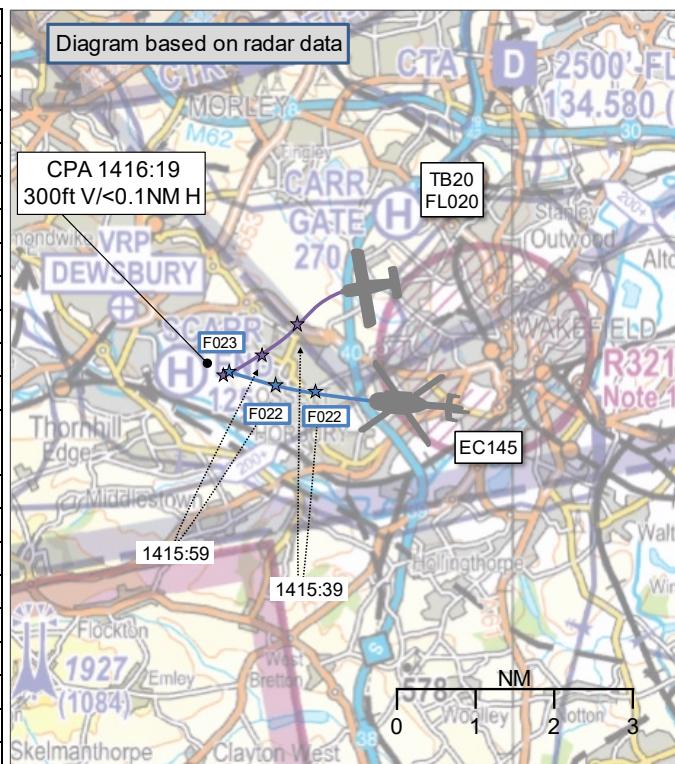
Recorded	Aircraft 1	Aircraft 2
Aircraft	EC145	TB20
Operator	HEMS	Civ FW
Airspace	London FIR	London FIR
Class	G	G
Rules	VFR	VFR
Service	Basic	Basic
Provider	Leeds Bradford	Leeds Bradford
Altitude/FL	FL023	FL020
Transponder	A, C, S+	A, C
Reported		
Colours	Yellow	White, Blue
Lighting	Anti-col, Nav, Landing	Beacon
Conditions	VMC	VMC
Visibility	>10km	>10km
Altitude/FL	2200-2500ft	2200ft
Altimeter	QNH (1020hPa)	QNH
Heading	280°	215°
Speed	125kt	105kt
ACAS/TAS	TCAS II	Not fitted
Alert	TA	N/A
Separation at CPA		
Reported	200ft V/<0.5NM H	50-100ft V/0.25-0.5NM H
Recorded	300ft V/<0.1NM H
