**AIRPROX REPORT No 2025195**

Date: 05 Sep 2025 Time: 1123Z Position: 5054N 00000E Location: 1NM N Lewes

**PART A: SUMMARY OF INFORMATION REPORTED TO UKAB**

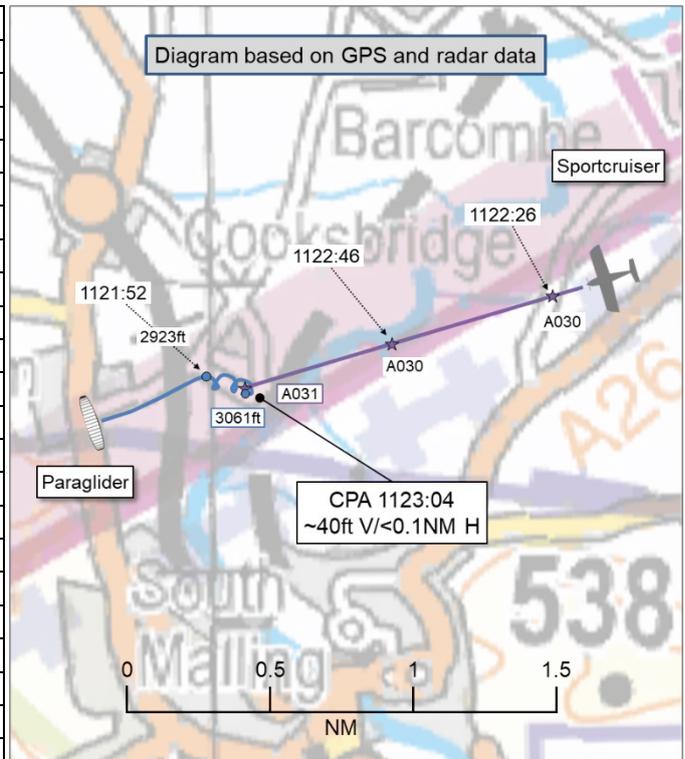
Recorded	Aircraft 1	Aircraft 2
Aircraft	Paraglider	SportCruiser
Operator	Civ Hang	Civ FW
Airspace	London FIR	London FIR
Class	G	G
Rules	VFR	VFR
Service	None	Basic
Provider	N/A	F'borough LARS E
Altitude/FL	3061ft	3100ft
Transponder	Not fitted	A, C, S
Reported		
Colours	White, orange	Red, white
Lighting	None	Strobes, nav
Conditions	VMC	VMC
Visibility	>10km	>10km
Altitude/FL	3000ft	3000ft
Altimeter	QNH	NR
Heading	<i>circling</i>	270°
Speed	20kt	100kt
ACAS/TAS	FLARM	PilotAware
Alert	None	None
Separation at CPA		
Reported	0ft V/30m H	<i>Not seen</i>
Recorded	~40ft V/<0.1NM H
