AIRPROX REPORT No 2025197

Date: 05 Sep 2025 Time: 1520Z Position: 5210N 00006E Location: 3.5NM SW Cambridge Airport

PART A: SUMMARY OF INFORMATION REPORTED TO UKAB

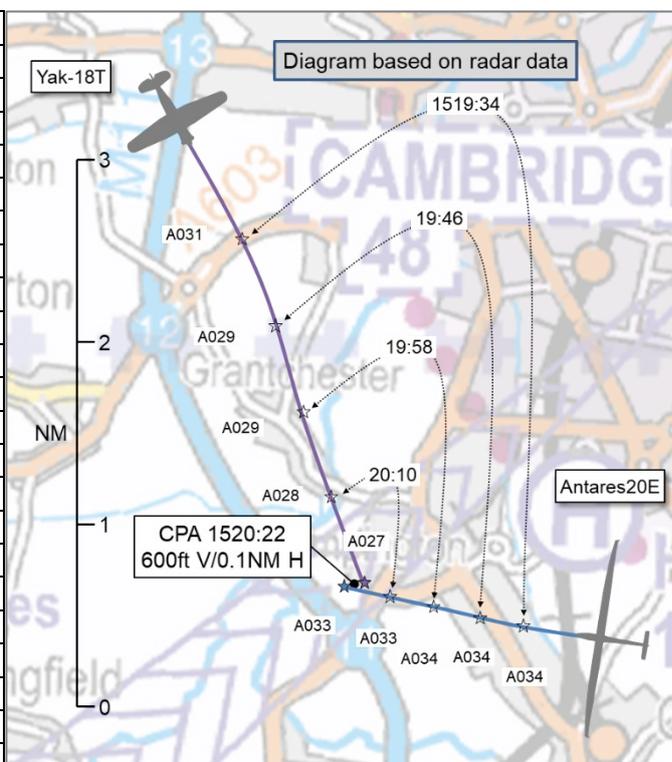
THE ANTARES PILOT reports [conducting a] cross-country flight. [They] contacted Cambridge Radar when routeing north of Cambridge, receiving [a] Basic Service and squawking 6196 (Mode S, no ADS-B in/out). [They] remained in contact with Cambridge Radar under their Basic Service. [They] called turning [at] Bury St Edmunds and returning to [the] west. [They] called after climbing west of Newmarket with position and height and advised [they would be] routeing round the south side of [the] Cambridge zone. [They] preferred not to route through [the] Cambridge overhead as incoming traffic was intending to route through the overhead. [They] routed [along the] southern edge of [the] Cambridge zone until able to take [a] direct route to [destination]. [They were] flying straight and level (gliding descent) when [they had a] late sighting of two low-wing single-engine aircraft in close formation around 250m to [their] right, flying straight and level, to pass underneath by maybe 250ft. [The aircraft], one yellow and the other natural metal colour, appeared to be routeing down [the] east of [the] M11, possibly enroute to Duxford. Converging courses probably contributed to [the] late sighting. [It was] not known if the other [pilots] saw [them]; [the other plots] were not in communication with Cambridge. [They] reported [the] Airprox to Cambridge Radar shortly afterwards and passed basic Airprox information and [their] contact details to Cambridge Radar.

THE YAK-18T PILOT reports leading a 2-ship formation flight recovering to [destination] from a relatively high altitude (8500ft) photo sortie to the north of the reported location. In the descent, the Lead aircraft [pilot] and wingman both saw [a] glider to the right and above, orbiting in the approximate reported position. [The] Lead aircraft [pilot] was happy that the rate of descent and forward speed provided sufficient clearance to the orbiting glider, passing below and to the east of the glider with an ever-increasing margin of vertical separation. [The] Lead aircraft [pilot] was particularly aware [of] traffic as a regular operator [in that area] and as the location is in the instrument approach area for Cambridge.

Seeing a glider orbiting in [that] location was somewhat of a surprise given the proximity to any instrument approach traffic.
