AIRPROX REPORT No 2025203

Date: 09 Sep 2025 Time: 1641Z Position: 5110N 00013E Location: 2.5NM NW Tunbridge Wells

PART A: SUMMARY OF INFORMATION REPORTED TO UKAB

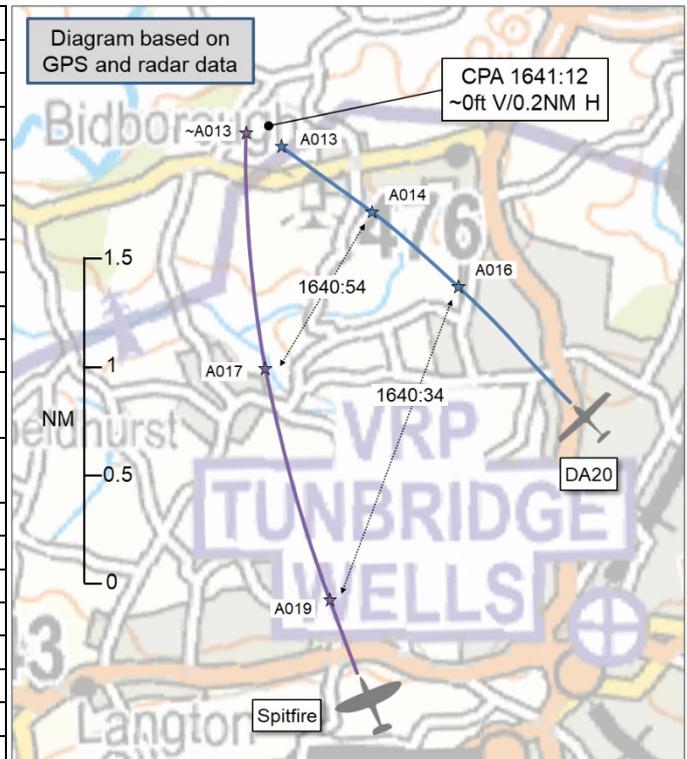
Recorded	Aircraft 1	Aircraft 2
Aircraft	DA20	Spitfire
Operator	Civ FW	Civ FW
Airspace	London FIR	London FIR
Class	G	G
Rules	VFR	VFR
Service	None ¹	None ²
Provider	N/A	N/A
Altitude/FL	1300ft	~1300ft
Transponder	A, C, S	A, C, S
Reported		
Colours	White	Camouflage, red markings
Lighting	Landing, taxi, position, strobes	None
Conditions	VMC	VMC
Visibility	>10km	>10km
Altitude/FL	1800ft	2000ft
Altimeter	QNH (1014hPa)	QNH
Heading	310°	330°
Speed	100kt	180kt
ACAS/TAS	Not fitted	SkyEcho
Alert	N/A	TA
Separation at CPA		
Reported	50ft V/<0.25NM H	NR
Recorded	~0ft V/0.2NM H
