**AIRPROX REPORT No 2025207**

Date: 23 Sep 2025 Time: 0920Z Position: 5150N 00217W Location: 3NM SW Gloucester

**PART A: SUMMARY OF INFORMATION REPORTED TO UKAB**

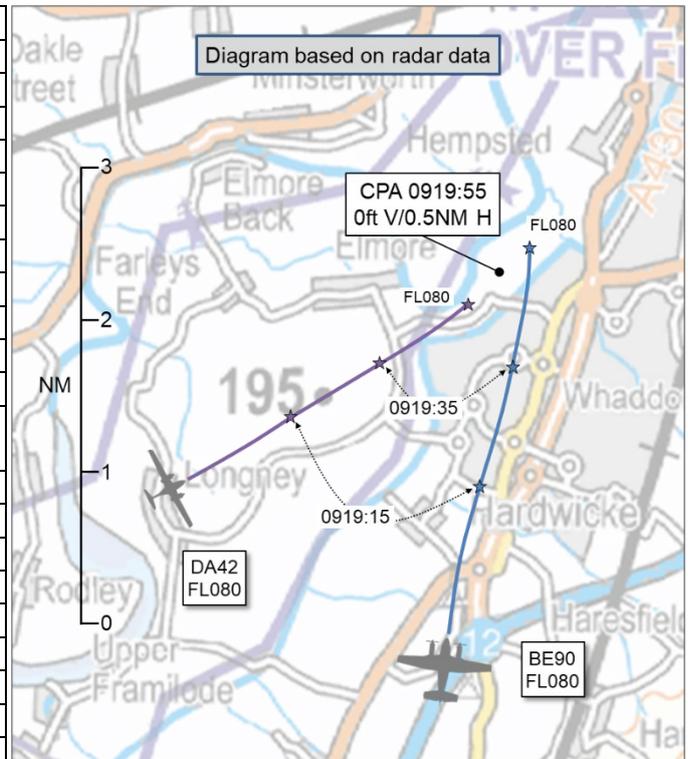
An analysis of the NATS radar replay was undertaken and both aircraft could be positively identified from Mode S data (Figure 1). The BE90, but not the DA42, was observed by reference to ADS-B data sources.
