AIRPROX REPORT No 2025208

Date: 19 Sep 2025 Time: 1127Z Position: 5119N 00005W Location: ivo Kenley Airfield

PART A: SUMMARY OF INFORMATION REPORTED TO UKAB

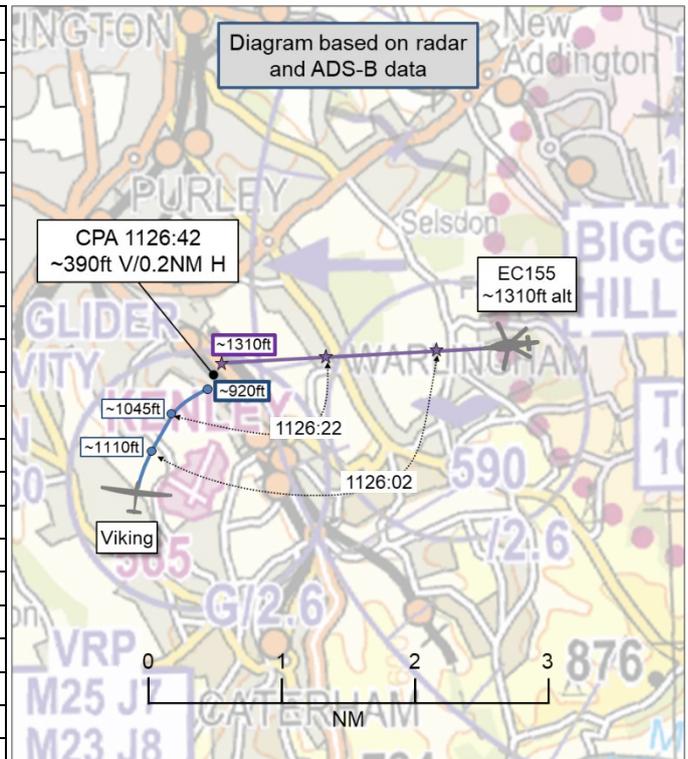
Recorded	Aircraft 1	Aircraft 2
Aircraft	Viking	EC155
Operator	HQ Air (Trg)	Civ Comm
Airspace	London FIR	London
Class	G	G
Rules	VFR	VFR
Service	AGCS (Mil)	Basic
Provider	Kenley Radio	Biggin Hill
Altitude/FL	920ft	1310ft
Transponder	Not fitted	A, C, S
Reported		
Colours	White/orange tips	Black
Lighting	NR	Anti-colls, nav
Conditions	VMC	VMC
Visibility	>10km	>10km
Altitude	500ft AGL	NK
Altimeter	QFE (1016hPa)	QNH
Heading	110°	NK
Speed	60kt	NK
ACAS/TAS	FLARM/SkyEcho ¹	TAS
Alert	None	Unknown
Separation at CPA		
Reported	150ft V/800m H	Not seen
Recorded	~390ft V/0.2NM H

THE VIKING PILOT reports that they turned on to base leg at approximately 500ft and selected the approach attitude. Upon reaching the approach attitude they noticed a large black helicopter in their 11 o'clock and 100ft above them. They altered their course to cut in towards the airfield and, a few seconds later, the helicopter altered course away from them by 10°.
