AIRPROX REPORT No 2025209

Date: 05 Sep 2025 Time: 1317Z Position: 5450N 00136W Location: Chester-Le-Street

PART A: SUMMARY OF INFORMATION REPORTED TO UKAB

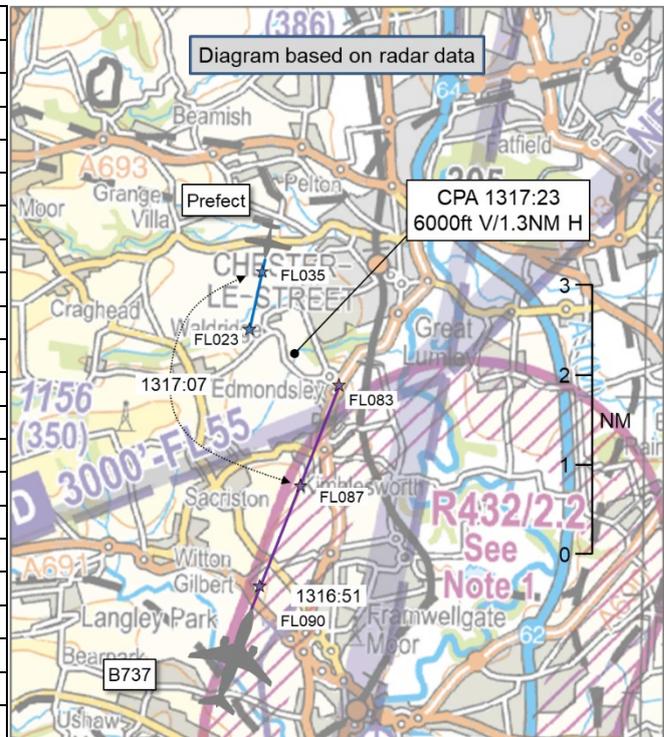
Recorded	Aircraft 1	Aircraft 2
Aircraft	Prefect	B737
Operator	HQ Air (Trg)	CAT
Airspace	London FIR	Borders CTA
Class	G	D
Rules	VFR	IFR
Service	Traffic	Radar Control
Provider	Newcastle Radar	Newcastle Radar
Altitude/FL	FL023	FL083
Transponder	A, C, S	A, C, S
Reported		
Colours	White and blue	Company
Lighting	Strobes, nav	Anti-col, strobes, nav
Conditions	NR	VMC
Visibility	NR	>10km
Altitude/FL	NR	4500ft
Altimeter	NR	QNH
Heading	NR	035°
Speed	NR	250kt
ACAS/TAS	TCAS I	TCAS II
Alert	None	None
	Separation at CPA	
Reported	Not seen	Not seen
Recorded	6000ft V/1.3NM H

THE NEWCASTLE CONTROLLER reports that the Prefect departed [...] to the south, initially below 2500ft. After multiple requests to report altitude, the pilot still did not respond correctly. The pilot eventually read back 3000ft, although Mode C indicated 2500ft. The controller confirmed the readback, and the pilot then advised climbing to 7000ft, entering controlled airspace contrary to ATC instructions. At the same time, the B737 was descending to 5000ft in the opposite direction. The controller instructed the Prefect pilot to descend immediately and remain outside controlled airspace and issued a right-turn avoiding action to the B737 twice; these instructions were initially not acknowledged. The Prefect pilot later confirmed descending and leaving CAS. The B737 pilot subsequently asked if the avoiding action was for them. Although separation did not reach a critical minimum, the lack of compliance and delayed responses increased the risk of conflict.
