AIRPROX REPORT No 2025213

Date: 26 Sep 2025 Time: 1438Z Position: 5230N 00214W Location: Wolverhampton

PART A: SUMMARY OF INFORMATION REPORTED TO UKAB

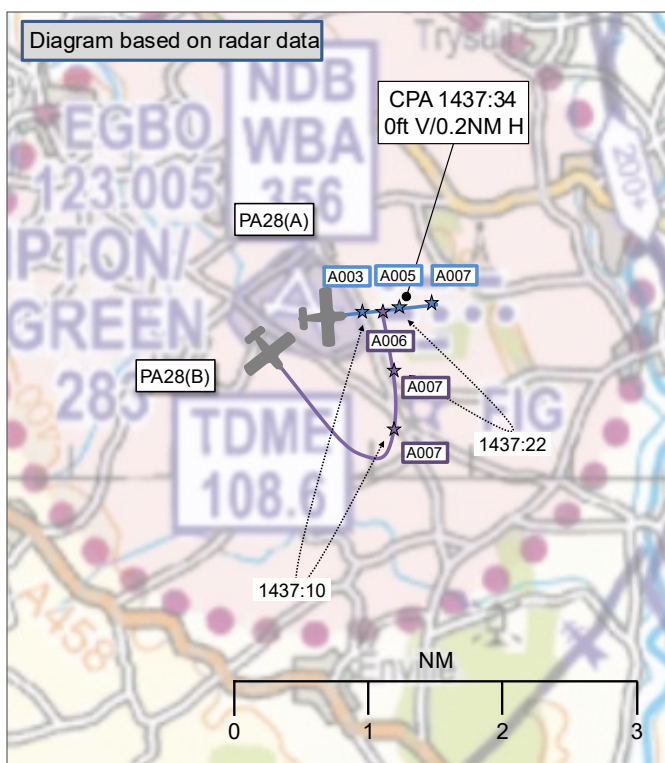
Recorded	Aircraft 1	Aircraft 2
Aircraft	PA28(A)	PA28(B)
Operator	Civ FW	Civ FW
Airspace	Wolverhampton ATZ	Wolverhampton ATZ
Class	G	G
Rules	VFR	VFR
Service	AFIS	AFIS
Provider	Wolverhampton Info	Wolverhampton Info
Altitude/FL	700ft	600ft
Transponder	A, C	A, C, S
Reported		
Colours	White	White, Blue
Lighting	None	Nav, Landing
Conditions	VMC	VMC
Visibility	>10km	>10km
Altitude/FL	600ft	500ft
Altimeter	QNH (1021hPa)	QFE
Heading	100°	100°
Speed	74kt	70kt
ACAS/TAS	Not fitted	Not fitted
Separation at CPA		
Reported	100ft V/750m H	500ft V/500ft H
Recorded	0ft V/0.2NM H
