AIRPROX REPORT No 2025214

Date: 27 Sep 2025 Time: 0933Z Position: 5140N 00055W Location: ivo of Stokenchurch

PART A: SUMMARY OF INFORMATION REPORTED TO UKAB

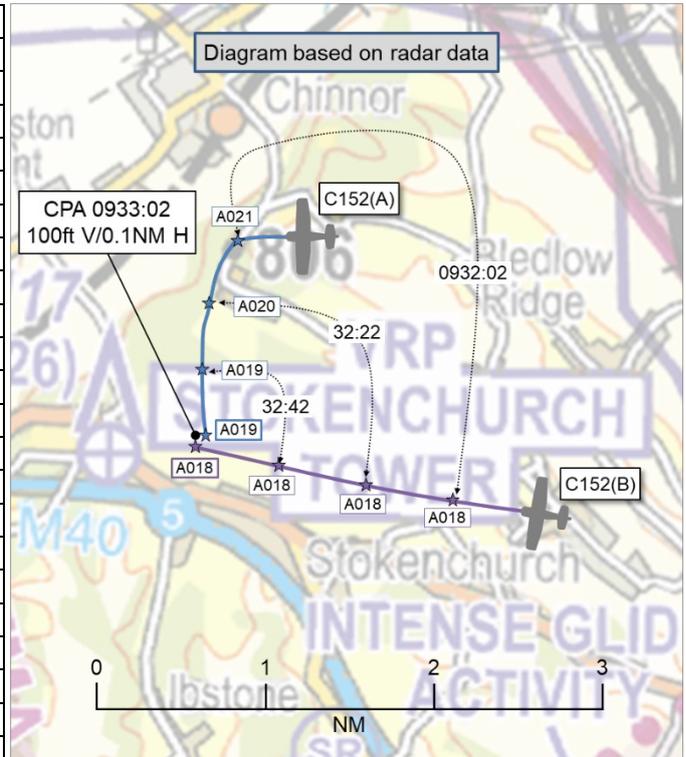
THE C152(A) PILOT reports that, 1-2min after turning from a northwest to a south-southwest heading, an aircraft passed 100ft-120ft beneath them. The Farnborough [North LARS controller] indicated the incident and the pilot acknowledged it. As the weather began to worsen enroute to [their intended destination], they returned to [base]. The weather was not a factor at the time of the incident as visibility was good.

An analysis of the NATS radar replay was undertaken and both aircraft were identified using Mode S data. CPA was assessed to have occurred at 0933:02 with 0.1NM lateral and 100ft vertical separation (Figure 5). Neither aircraft was observed with reference to ADS-B data sources.
