AIRPROX REPORT No 2025223

Date: 07 Oct 2025 Time: 1504Z Position: 5358N 00038W Location: 3NM SW Wetwang

PART A: SUMMARY OF INFORMATION REPORTED TO UKAB

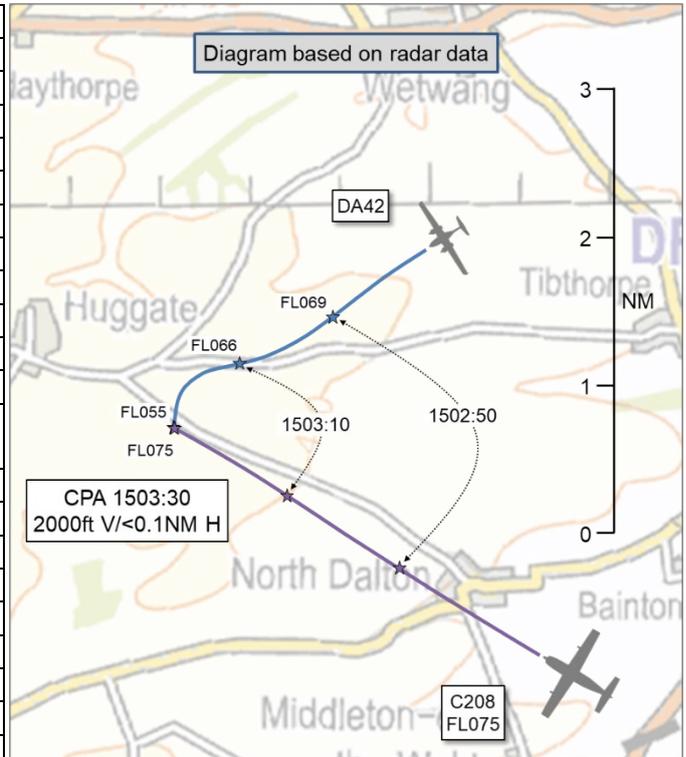
| Recorded | Aircraft 1 | Aircraft 2 |
|---|---|---|
| Reported | 200ft V/0.5NM H | 1000ft V/NR H |
| Recorded | 2000ft V/<0.1NM H | |
