AIRPROX REPORT No 2025228

Date: 30 Oct 2025 Time: 1118Z Position: 5222N 00130W Location: Coventry ATZ

PART A: SUMMARY OF INFORMATION REPORTED TO UKAB

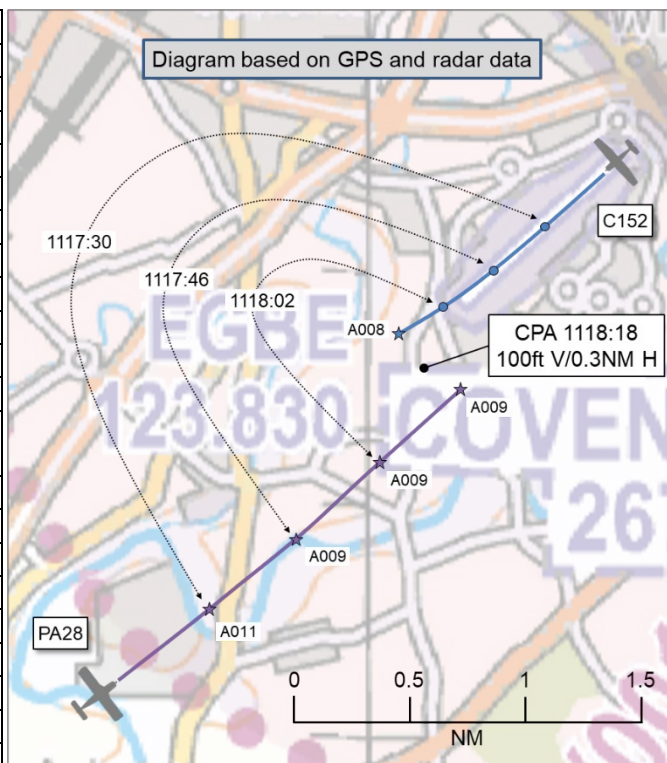
THE C152 PILOT reports that, at approximately 1119, during a dual training flight, they were in the circuit at Coventry aerodrome. On the climbout from RW23LH at approximately 700ft QNH, their student noticed an approaching aircraft on their left-hand side (in their 10 o'clock at an estimated range of 500m). The student began turning to the right and called “*aircraft sighted*”. They estimate a minimum lateral separation of 200m while it was slightly above them and climbing away. It passed on their left-hand side, in the opposite direction, apparently joining on an extremely tight downwind leg (but not the published one).

THE COVENTRY AFISO reports that, at approximately 1115, [the pilot of the C152] was flying non-standard circuits, well inside the published circuit pattern practising glide approaches. [The pilot of an uninvolved PA28] had recently departed from RW23 to the south-east. [The pilot of the Airprox PA28]

reported inbound at 10NM from the west and requested a downwind join. Whilst booking PPR, the pilot had discussed joining via Draycote Water as per the published procedure in the UK AIP. [The pilot of the C152] then called final for a touch-and-go.

Approximately two minutes later, [the pilot of the Airprox PA28] called joining downwind much earlier than expected. Looking up, they saw a PA28 at the start of the downwind leg where traffic would have been expected to be joining. They later realised that that was [the uninvolved PA28 leaving the airfield to the south-east], and they replied, “*report final, one ahead on short final*”. The Coventry AFISO then reiterated the squawk of 0420 as the squawk was not correctly read back after the initial call.
