AIRPROX REPORT No 2025232

Date: 08 Nov 2025 Time: 1210Z Position: 5159N 00106W Location: 4NM S of Turweston

PART A: SUMMARY OF INFORMATION REPORTED TO UKAB

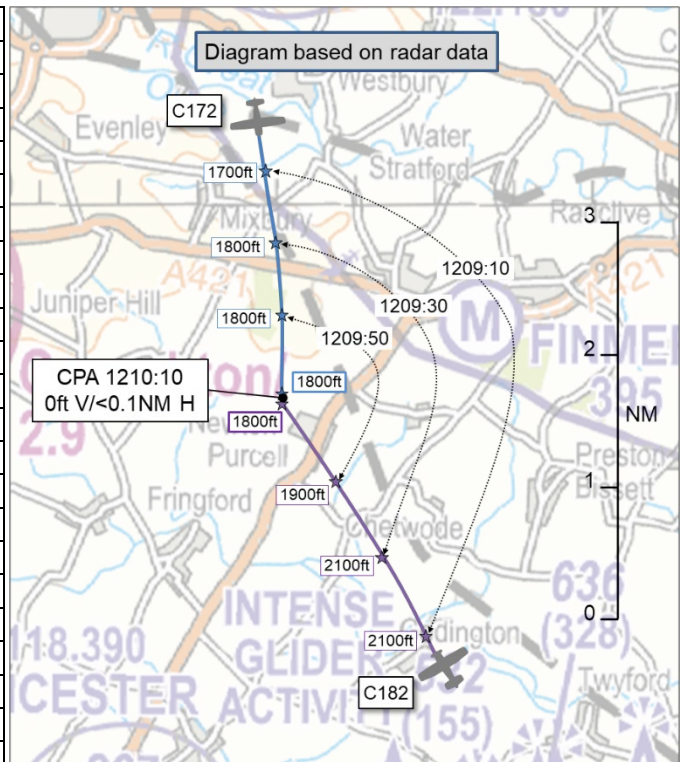
Recorded	Aircraft 1	Aircraft 2
Aircraft	C172	C182
Operator	Civ FW	Civ FW
Airspace	London FIR	London FIR
Class	G	G
Rules	VFR	VFR
Service	Listening Out ¹	Listening Out
Provider	Turweston Radio	Turweston Radio
Altitude	1800ft	1800ft
Transponder	A, C, S+	A, C, S
Reported		
Colours	White and red.	White and blue.
Lighting	Bcn, nav, strobes.	Ldg, taxi, nav, bcn.
Conditions	VMC	VMC
Visibility	5-10km	>10km
Altitude	1800ft	1700ft
Altimeter	QNH (1013hPa)	QNH (1013hPa)
Heading	180°	330°
Speed	95kt	125kt
ACAS/TAS	PilotAware	Safesky
Alert	Information	None
Separation at CPA		
Reported	0ft V/<0.5NM H	5ft V/70m H
Recorded	0ft V/<0.1NM H
