AIRPROX REPORT No 2025233

Date: 08 Nov 2025 Time: 1143Z Position: 5204N 00105W Location: IVO Turweston

PART A: SUMMARY OF INFORMATION REPORTED TO UKAB

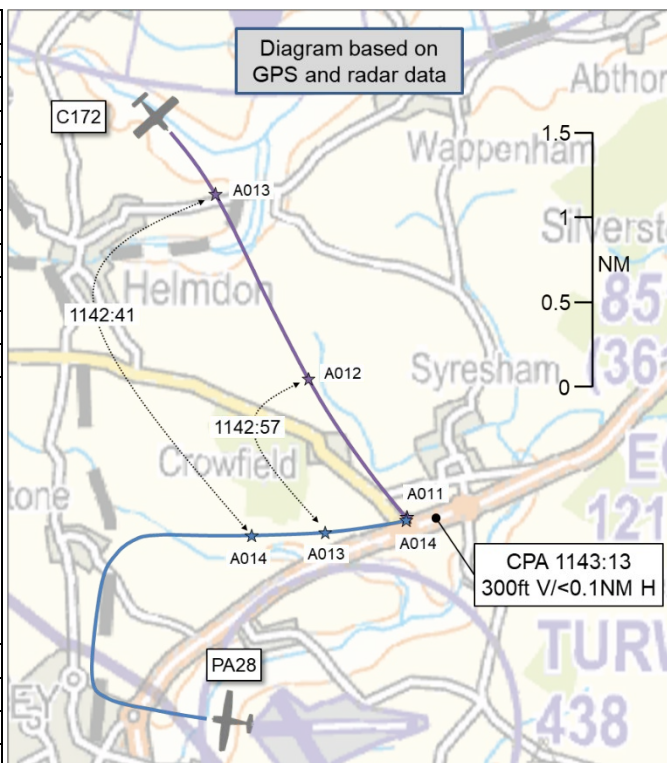
An analysis of the NATS radar replay was undertaken and both aircraft could be positively identified from Mode S data. The pilot of the PA28 kindly supplied GPS track data for their flight. The C172, but not the PA28, was observed by reference to ADS-B data sources. The diagram was constructed and the separation at CPA determined by combining the data sources.
