AIRPROX REPORT No 2025234

Date: 08 Nov 2025 Time: 1516Z Position: 5231N 00214W Location: Wolverhampton

PART A: SUMMARY OF INFORMATION REPORTED TO UKAB

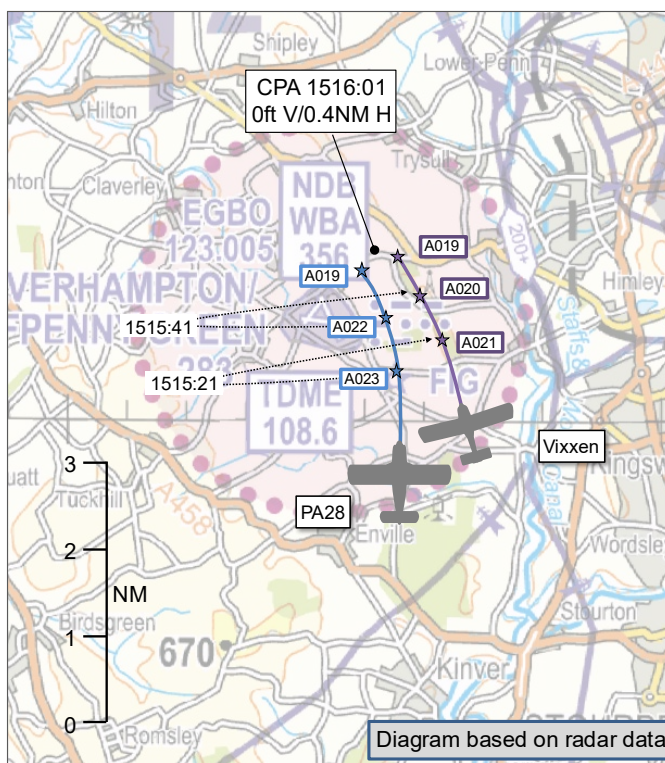
Recorded	Aircraft 1	Aircraft 2
Aircraft	PA28	Vixxen
Operator	Civ FW	Civ FW
Airspace	Wolverhampton ATZ	Wolverhampton ATZ
Class	G	G
Rules	VFR	VFR
Service	AFIS	AFIS
Provider	Wolverhampton Info	Wolverhampton Info
Altitude/FL	1900ft	1900ft
Transponder	A, C, S	A, C, S
Reported		
Colours	Blue	Red
Lighting	Nav	Landing, Strobe, Nav, Anti-cols
Conditions	VMC	VMC
Visibility	>10km	>10km
Altitude/FL	2000ft	1900ft
Altimeter	QFE (1003hPa)	QFE
Heading	NW	340°
Speed	100kt	85kt
ACAS/TAS	TAS	PilotAware
Alert	None	None
Separation at CPA		
Reported	0ft V/200ft H	'slightly above'
Recorded	0ft V/0.4NM H
