**AIRPROX REPORT No 2025242**

Date: 24 Nov 2025 Time: 1341Z Position: 5247N 00254W Location: 1NM NNE of Nesscliffe

**PART A: SUMMARY OF INFORMATION REPORTED TO UKAB**

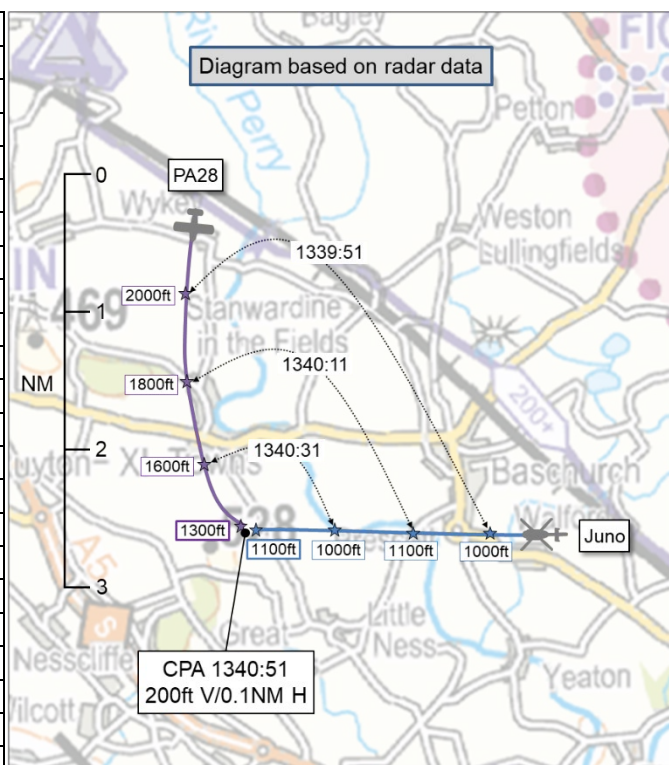
**THE JUNO PILOT** reports that their aircraft was westbound toward Nesscliffe Hill at 1000ft QNH, at 110kt under a Basic Service. They had a [TAS] audible warning of an aircraft, on their right, 3 o'clock position, 2NM. The [TAS] visually indicated a yellow tag right of their aircraft and 500ft above them. The crew members looked right of their aircraft to identify the conflict. The non-handling pilot looked forward and saw the aircraft bearing in the half-past 12 position, opposite direction, approximately 300ft above them. The non-handling pilot warned the crew and prompted for the aircraft to descend. The sortie continued without further incident.

In concluding their discussion, the Board noted that the developing conflict between the Juno and the PA28 had likely been unmonitored and undetected until the Juno pilot had received a TA on the PA28. Members agreed that safety had been degraded, but that the Juno pilot had taken timely and effective avoiding action away from the PA28. As such, the Board assigned Risk Category C to this event.
