AIRPROX REPORT No 2026004

Date: 03 Jan 2026 Time: 1436Z Position: 5121N 00032W Location: Fairoaks ATZ

PART A: SUMMARY OF INFORMATION REPORTED TO UKAB

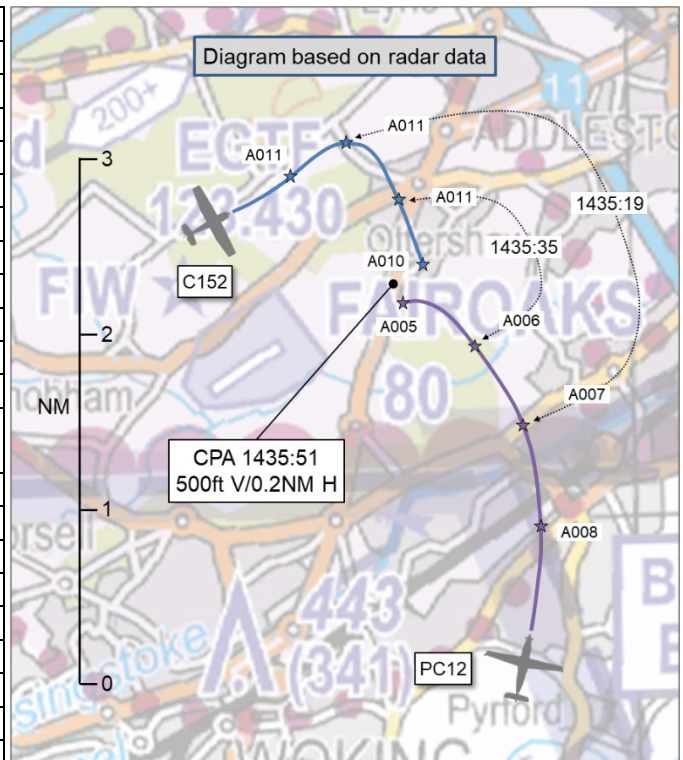
Recorded	Aircraft 1	Aircraft 2
Aircraft	C152	PC12
Operator	Civ FW	Civ Comm
Airspace	Fairoaks ATZ	Fairoaks ATZ
Class	G	G
Rules	VFR	VFR
Service	AGCS	AGCS
Provider	Fairoaks Radio	Fairoaks Radio
Altitude/FL	A010	A005
Transponder	A, C, S	A, C, S+
Reported		
Colours	White	Grey, black
Lighting	Nav, beacon, landing	Nav, beacon, strobes, landing
Conditions	VMC	VMC
Visibility	>10km	>10km
Altitude/FL	1100ft	NK
Altimeter	QNH	QNH
Heading	150°	NK
Speed	90kt	120kt
ACAS/TAS	SkyEcho	TCAS II
Alert	Information	None
	Separation at CPA	
Reported	200ft V/0.5NM H	300ft V/2NM H
Recorded	500ft V/0.2NM H

An analysis of the NATS radar replay was undertaken and both aircraft could be positively identified from Mode S data. Both aircraft were also observed by reference to ADS-B data sources. The diagram was constructed and the separation determined from the radar data.
