**AIRPROX REPORT No 2026005**

Date: 16 Jan 2026 Time: 1301Z Position: 5155N 00210W Location: Gloucester Airport

**PART A: SUMMARY OF INFORMATION REPORTED TO UKAB**

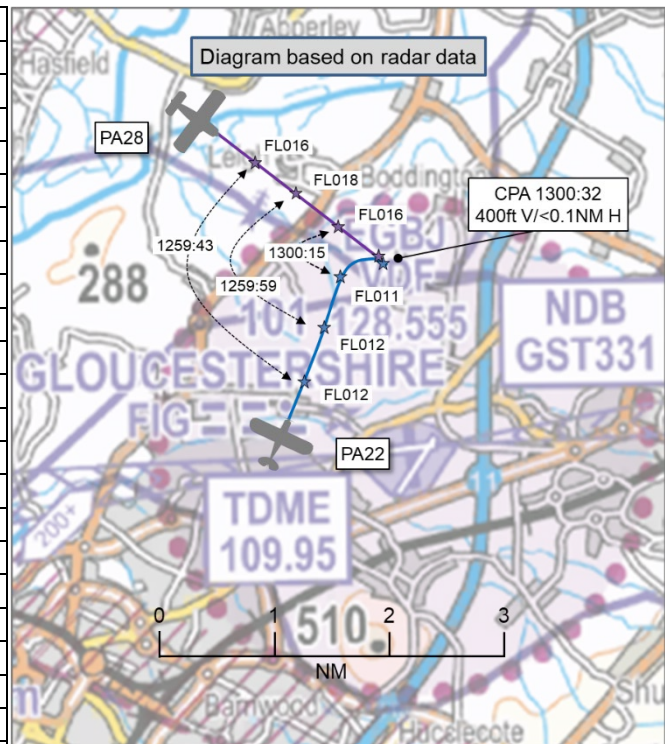
Recorded	Aircraft 1	Aircraft 2
Aircraft	PA22	PA28
Operator	Civ FW	Civ FW
Airspace	Gloucester ATZ	Gloucester ATZ
Class	G	G
Rules	VFR	VFR
Service	ACS	ACS
Provider	Gloster Tower	Gloster Tower
Altitude/FL	FL010	FL014
Transponder	A, C, S	A, C, S
<b>Reported</b>		
Colours	Cream, red	White, red
Lighting	Bcn	Nav, Anti-col, Strobe
Conditions	VMC	VMC
Visibility	>10km	>10km
Altitude/FL	800ft AGL	1200ft
Altimeter	QFE (1003hPa)	QNH (1005hPa)
Heading	130°	130°
Speed	85kt	90kt
ACAS/TAS	PilotAware+ADS-B out	Not fitted
Alert	None	N/A
	<b>Separation at CPA</b>	
Reported	175ft V/20m H	Not seen
Recorded	400ft V/<0.1NM H
