**AIRPROX REPORT No 2026015**

Date: 03 Mar 2026 Time: 1144Z Position: 5256N 00332W Location: 2.5NM NE of Bala

**PART A: SUMMARY OF INFORMATION REPORTED TO UKAB**

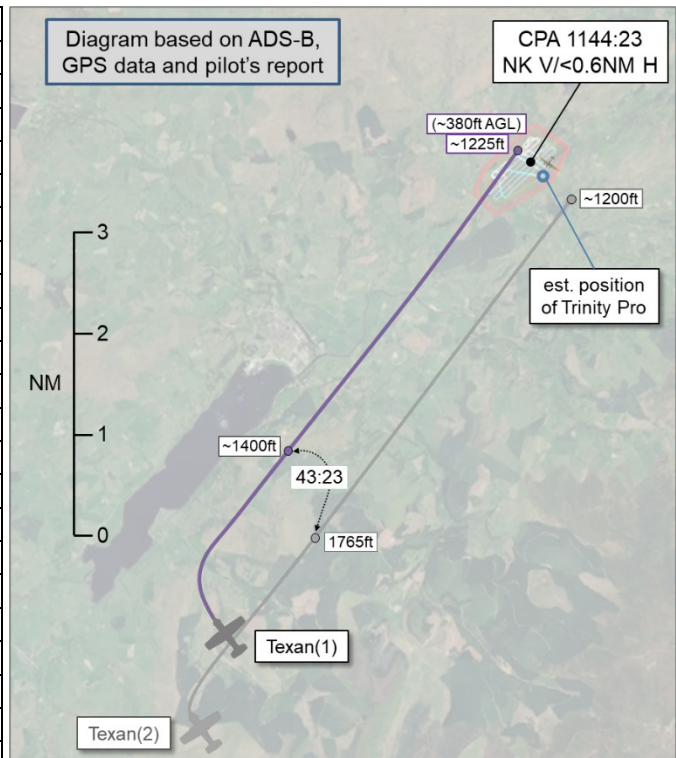
**THE TRINITY PRO PILOT** reports that two aircraft visually went either side of their UAS at a barometric altitude of approximately 1200ft. The elevation of the site is 846ft and the UAS was terrain following at a height of 328ft, thus their GPS altitude was 1174ft. Depending on the QNH at the time, this could have placed all three aircraft at a similar height.

**THE TEXAN(1) PILOT** reports that the formation [crew] unknowingly flew close to a drone operating at 3NM north of Bala. Neither aircraft [pilot] saw the drone, which was not visible on the HUD tape review. [They added that] they had a low workload with two pilots looking out. There was no NOTAM, CADS submission or [other information] published to notify them of this activity.

Bringing their discussion to a close, members agreed that neither the Texan pilot nor the Trinity Pro pilot had had situational awareness of the other aircraft, and that the Texan pilot had not seen the Trinity Pro nor had the Trinity Pro pilot seen the Texan pair until too late to react. While some members had felt that safety had been much reduced (risk B), overall, the Board agreed that, while safety had been degraded, there had been adequate lateral separation (~0.6NM) between Texan(1) and the drone. As such, the Board assigned Risk Category C to this event.

Following this [Company] review, it is recommended that all fixed-wing UAS flights shall be subject to a NOTAM as the aircraft cannot rapidly descend. Whilst a NOTAM does not guarantee deconfliction, the military and other government aircraft [pilots] are known to look at NOTAMs before deploying and it may have initiated communication between RAF Valley and the Pilot-in-Command (as it has in the past with RAF Valley).

It is also recommended that the CAA is contacted and a request made for a permanent licence to operate the Ping-20's ADS-B out/Mode-S transponder that [the Trinity Pro] carries (as opposed to the Test and Evaluation license currently held). The Mode-S transponder may have been visible on the Texan's TCAS.
