AIRPROX REPORT No 2026018

Date: 10 Mar 2026 Time: 1048Z Position: 5124N 00129W Location: E of Hungerford

PART A: SUMMARY OF INFORMATION REPORTED TO UKAB

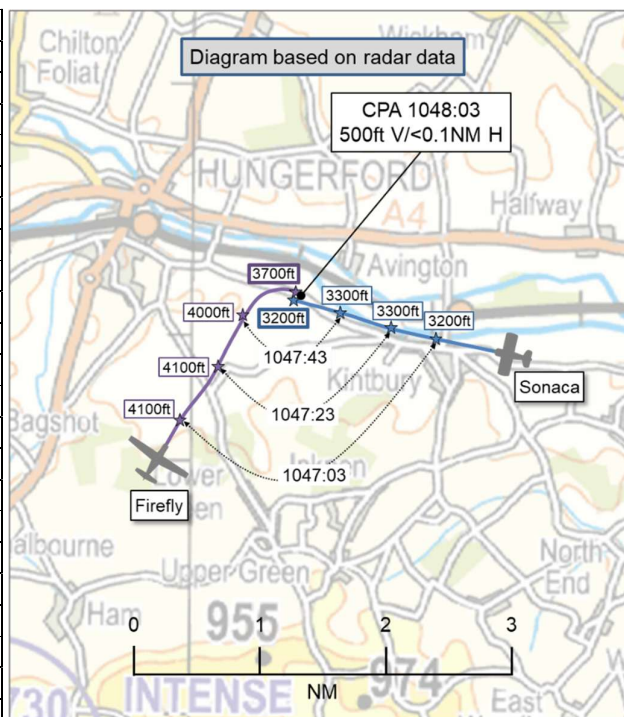
THE SONACA PILOT reports that during the flight they came in close proximity to another aircraft. The visibility was 10km or more with a layer of scattered cloud from approximately 2400ft to 2800ft. After their departure, they received a Basic Service from Farnborough Radar on 125.250MHz, which was terminated just before reaching Hungerford at approximately 1046. They were in the process of changing frequency to Brize Radar when the incident occurred. At this time [their student] was flying the aircraft on a heading of 260° at 3200ft and 85kt. At approximately 1047, an aircraft was sighted approximately 300ft above them on a reciprocal heading, which appeared to be flying straight and level. Just prior to the aircraft passing overhead at approximately 1048, the other aircraft inverted and initiated a vertical dive/descent. They immediately took control and initiated a descending left turn to avoid the other aircraft, which appeared to be descending vertically toward them at high speed. [The Sonaca pilot's] descent was maintained at approximately 130kt down to 2000ft, at which point they determined that the other aircraft was no longer a factor and handed back control to [the student] who resumed their planned flight without further incident.

The pilot assessed the risk of collision as 'High'.
