**AIRPROX REPORT No 2026020**

Date: 14 Mar 2026 Time: 1138Z Position: 5413N 00115W Location: 1.5NM W Sutton Bank

**PART A: SUMMARY OF INFORMATION REPORTED TO UKAB**

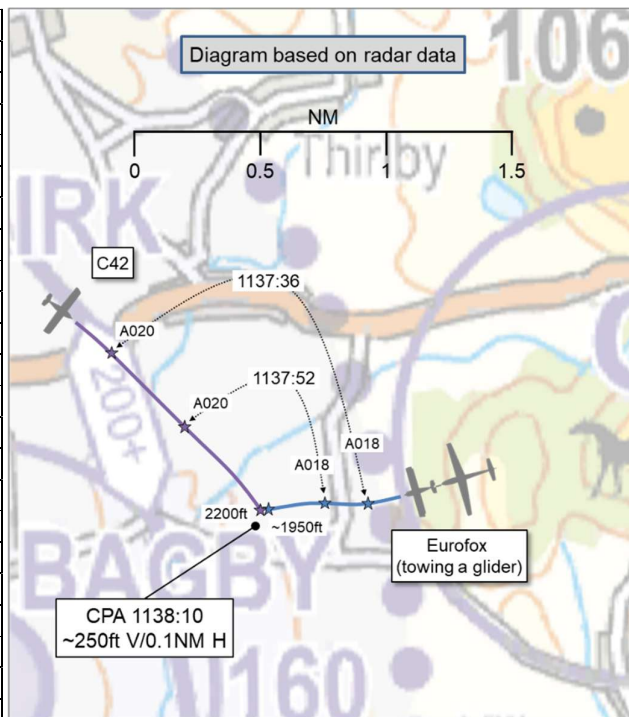
Recorded	Aircraft 1	Aircraft 2
Aircraft	Eurofox	C42
Operator	Civ FW	Civ FW
Airspace	London FIR	London FIR
Class	G	G
Rules	VFR	VFR
Service	None	Listening Out
Provider	N/A	Leeming LARS
Altitude/FL	~1950ft	2200ft
Transponder	A, C, S	A, C, S+
<b>Reported</b>		
Colours	Yellow	White
Lighting	Landing, nav	Nav, strobe
Conditions	VMC	VMC
Visibility	>10km	5-10km
Altitude/FL	1100ft	NK
Altimeter	QFE	QFE (995hPa)
Heading	250°	150°
Speed	75kt	80kt
ACAS/TAS	FLARM	PilotAware
Alert	None	None
	<b>Separation at CPA</b>	
Reported	100ft V/100m H	500ft V/500ft H
Recorded	~250ft V/0.1NM H

An analysis of the NATS radar replay was undertaken and both aircraft could be positively identified from Mode S data. The aircraft were depicted as having flown at Flight Levels and a suitable correction was applied to determine their altitudes. The C42, but not the Eurofox, could be observed by reference to ADS-B data sources.
