AIRPROX REPORT No 2026024

Date: 19 Mar 2026 Time: 1435Z Position: 5116N 00016W Location: 3.5NM NE Dorking

PART A: SUMMARY OF INFORMATION REPORTED TO UKAB

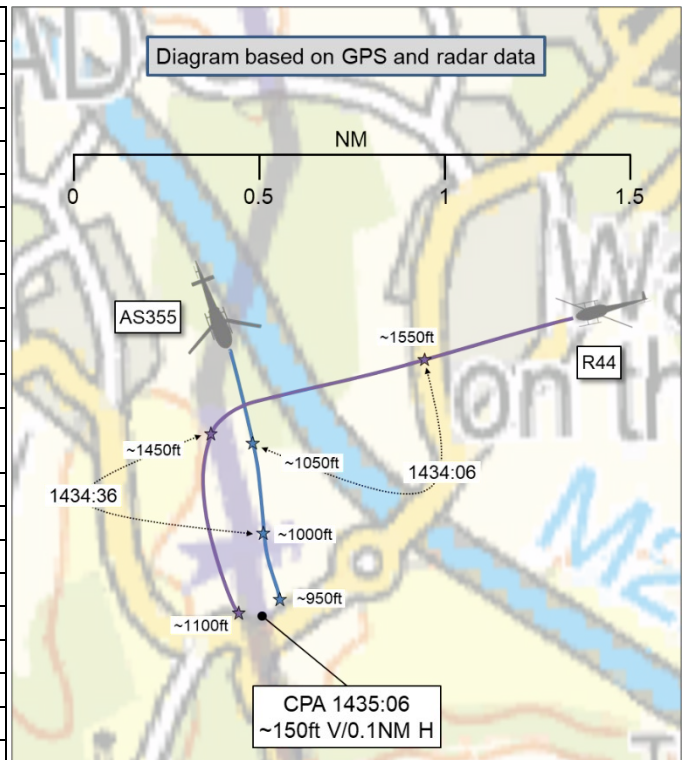
Recorded	Aircraft 1	Aircraft 2
Aircraft	AS355	R44
Operator	Civ Comm	Civ Helo
Airspace	London FIR	London FIR
Class	G	G
Rules	VFR	VFR
Service	Basic	Listening Out
Provider	Farnboro' LARS W	Farnboro' LARS W
Altitude/FL	~950ft	~1100ft
Transponder	A, C, S	A, C, S
Reported		
Colours	Blue	Grey
Lighting	Strobe, Anti-col, Nav	Nav
Conditions	VMC	VMC
Visibility	>10km	>10km
Altitude/FL	150ft	1050ft
Altimeter	QNH (1024hPa)	QNH
Heading	180°	180°
Speed	"hovering"	40kt
ACAS/TAS	TCAS I	Not fitted
Alert	None	N/A
Separation at CPA		
Reported	0ft V/30m H	200ft V/200m H
Recorded	~150ft V/0.1NM H

An analysis of the NATS radar replay was undertaken and both aircraft could be positively identified from Mode S data (Figure 1). Neither aircraft could be observed by reference to ADS-B data sources. Both pilots kindly supplied GPS track data for their flights. It was by combining the data sources that the diagram was constructed. The vertical separation at CPA was determined from the GPS track data, and has been shown in the diagram as an approximate value due to rounding.
