**AIRPROX REPORT No 2026032**

Date: 26 Mar 2026 Time: 1206Z Position: 5101N 00038W Location: 1NM SSW of MID VOR/DME

**PART A: SUMMARY OF INFORMATION REPORTED TO UKAB**

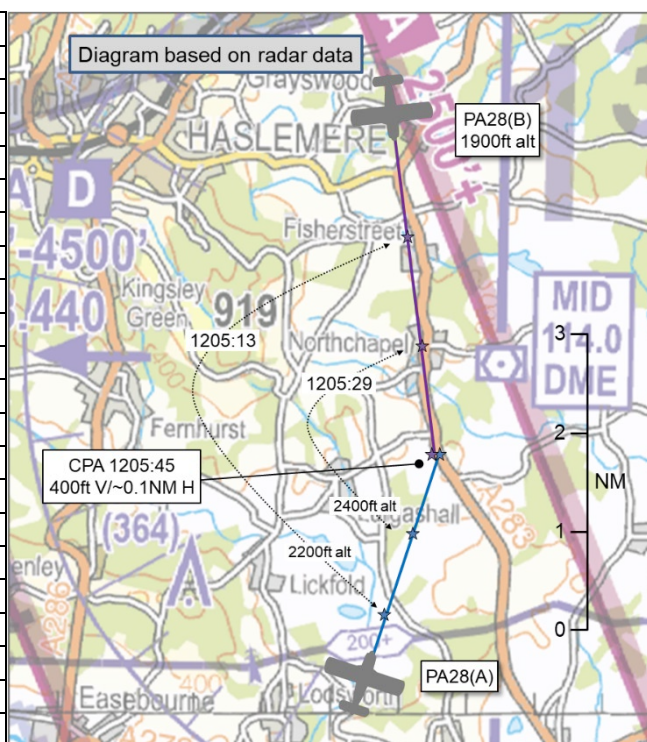
The pilot of PA28(A) contacted the Farnborough LARS frequency at 1134:27 (all times UTC), requested a Basic Service and reported approaching Guildford at altitude 1400ft tracking south to the coast. The pilot of PA28(B) contacted the frequency at 1151:54 and reported approaching M3 J4 and was initially instructed to take up a hold due to Farnborough inbound traffic and was subsequently provided with a Radar Control Service for their transit of the Farnborough Zone. Once clear of the Zone, the pilot was informed it would be a Basic Service outside CAS, which was acknowledged by the pilot. The pilot of PA28(B) was instructed to re-call the controller on the LARS West frequency at 1159:46 and issued a new squawk of 0435. PA28(A) was subsequently returning to [...] on a northerly track maintaining altitude 2300ft. PA28(B) was maintaining 1900ft on an opposite direction track to PA28(A). It was perceived that both aircraft were tracking towards the MID VOR.

At 1205:44, the two aircraft passed with 400ft vertical and 0.1NM lateral distance. This was assessed as the closest point of approach. The lateral tracks of the two aircraft did not change. Neither pilot reported the confliction on frequency.

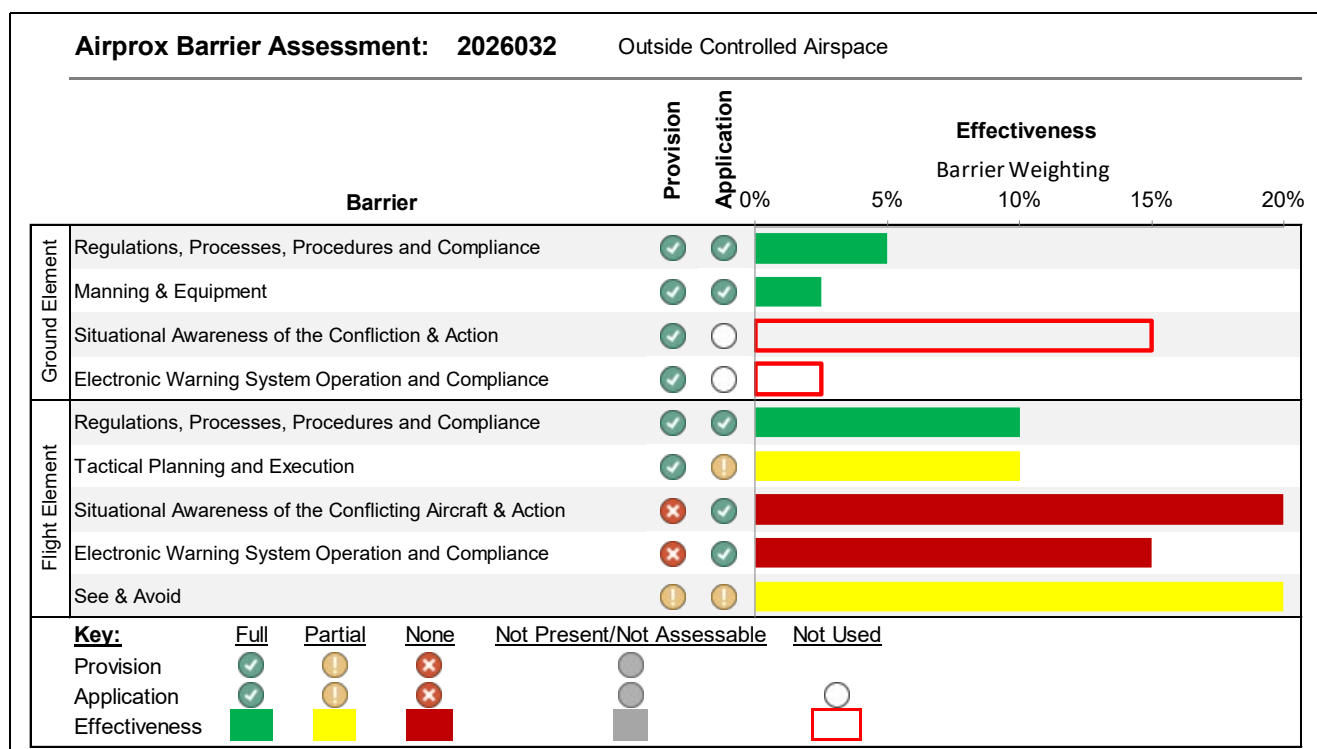
**Electronic Warning System Operation and Compliance** were assessed as **ineffective** because the conspicuity equipment carried by PA28(B) had been unable to register any electronic emissions from PA28(A).

**See and Avoid** were assessed as **partially effective** because the PA28(A) pilot had been distracted whilst switching fuel tanks, and both pilots had achieved only late sightings of the other aircraft.
