**AIRPROX REPORT No 2026033**

Date: 26 Mar 2026 Time: 1426Z Position: 5101N 00238W Location: RNAS Yeovilton

**PART A: SUMMARY OF INFORMATION REPORTED TO UKAB**

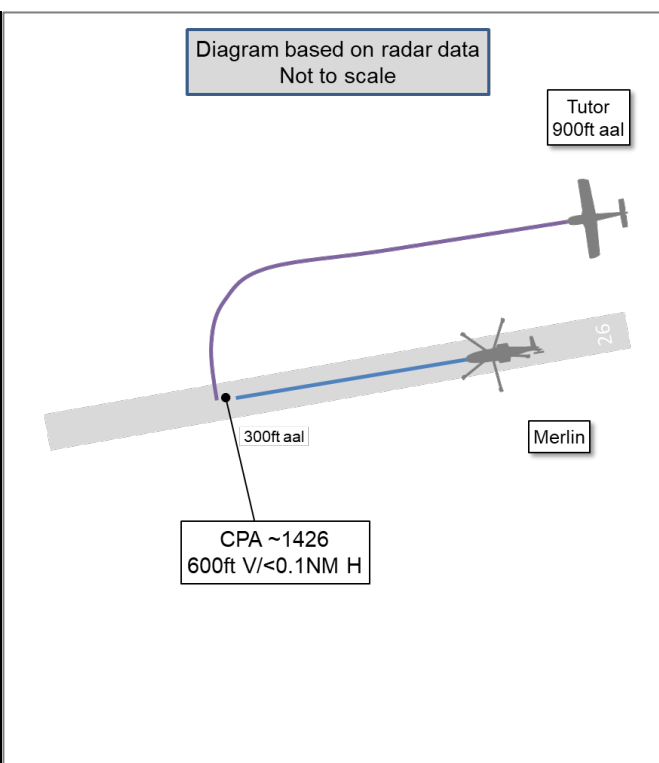
**THE MERLIN PILOT** reports that, during take-off from the duty runway, in the climb at a height of 250ft, the crew received a Traffic Advisory (TA) audio alert from the TAS, "Traffic, high, 1 o'clock less than 1 mile". Initially they couldn't see anything, but [by] moving their head forward they saw a Tutor which had been obscured by the overhead console. [The] aircraft was approximately 150ft above at a range of about 150m. [The] climb was stopped, at which point the Tutor crossed ahead, and the Merlin pilot routed behind it and then continued the climb. They contacted [the] Tower [controller] and stated they were not happy with the separation from the Tutor, at which point the [Tutor pilot] stated they had been visual throughout. Despite this, the Merlin pilot genuinely believed, had they not received the TA and stopped the climb, a real risk of collision existed. After discussing the incident, they informed [the] Approach [controller] of their intention to submit an Airprox.

**THE TUTOR PILOT** reports conducting a visual recovery via initial. They were deadside at 800ft and 100kt, visual with another Tutor(B) on downwind and the Merlin on RW26. [They] remained visual with the Merlin transitioning from the runway, noted they remained well below and behind as procedurally expected [and] so conducted [the] turn onto downwind. The Merlin [pilot] then told [the Tower controller] that the Tutor was far too close and asked for a phone number to ring when they landed. The Tutor pilot informed them they were visual throughout, continued the circuit to land and explained the event to the duty authoriser during the in-brief.
