**AIRPROX REPORT No 2026041**

Date: 03 Apr 2026 Time: 1512Z Position: 5153N 00015W Location: 5NM E Luton

**PART A: SUMMARY OF INFORMATION REPORTED TO UKAB**

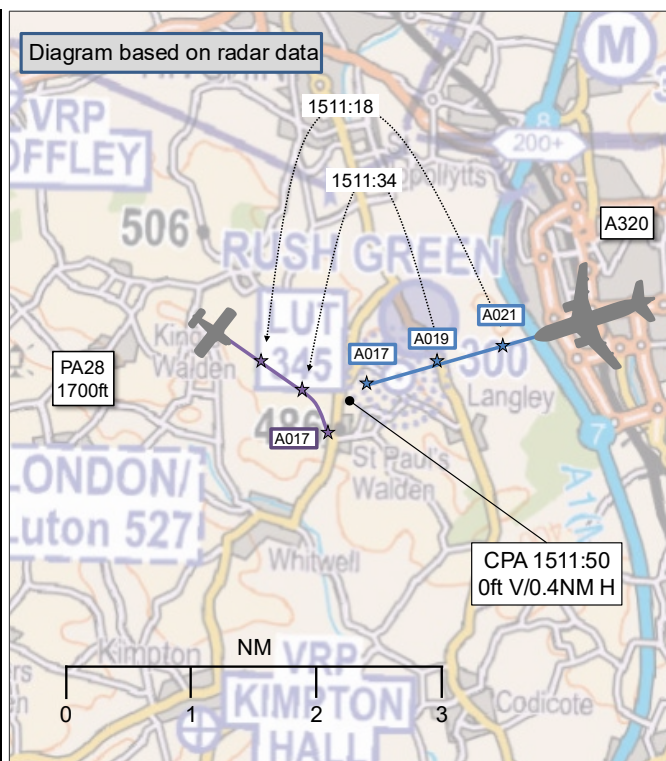
| Recorded | Aircraft 1 | Aircraft 2 |
|---|---|---|
| Recorded | 0ft V/0.4NM H | |

**THE A320 PILOT** reports that, on initial approach, ATC informed the crew of a light aircraft holding to the north of the airfield - this was seen on TCAS. Later, the light aircraft was warned that it was getting close to the approach and was instructed to make a turn to the north. The light aircraft continued to track south, crossing in front of the A320 at approximately 2000ft, around 1 mile in front. TCAS blue (autopilot TCAS where it would [execute] the RA manoeuvre for the crew if triggered and when green) was armed but no TCAS RA was triggered. An uneventful landing followed.

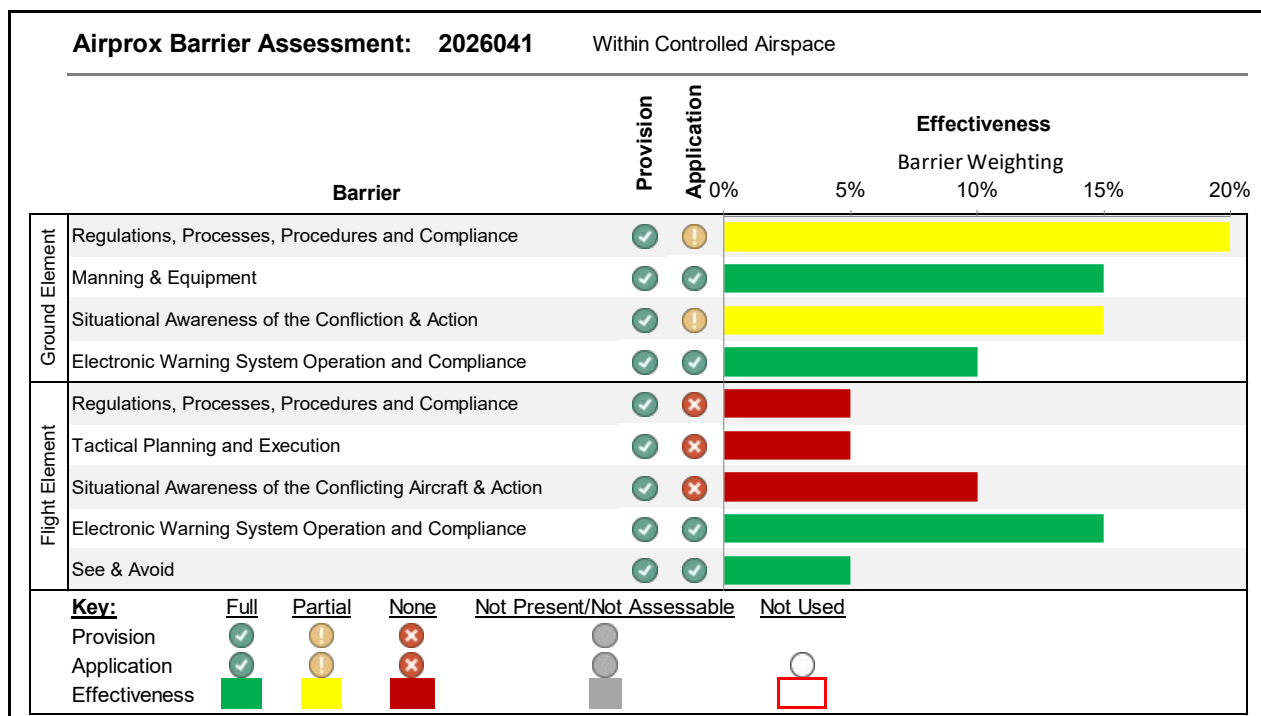
**Tactical Planning and Execution** was assessed as **ineffective** because the PA28 pilot did not follow the ATC clearance to hold 2NM north of the airfield and, when instructed to turn north by the Tower controller, although the pilot reported that they would, they continued on a southerly heading.

**Situational Awareness of the Conflicting Aircraft and Action** were assessed as **ineffective** because the PA28 pilot did not assimilate the Traffic Information that the A320 was on the approach, and continued on their southerly track.
