**AIRPROX REPORT No 2026043**

Date: 10 Apr 2026 Time: 0939Z Position: 5355N 00300W Location: 9NM N Blackpool Airport

**PART A: SUMMARY OF INFORMATION REPORTED TO UKAB**

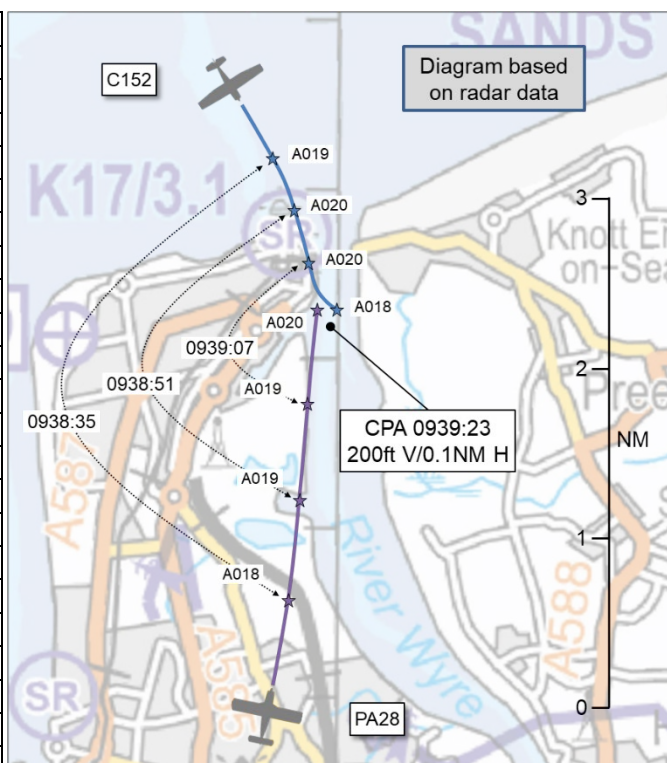
An analysis of the NATS radar replay was undertaken and both aircraft could be positively identified from Mode S data (Figure 1). Neither aircraft was observed by reference to ADS-B data sources.
