**AIRPROX REPORT No 2026045**

Date: 18 Apr 2026 Time: ~1121Z Position: 5050N 00114W Location: Lee-on-Solent ATZ

**PART A: SUMMARY OF INFORMATION REPORTED TO UKAB**

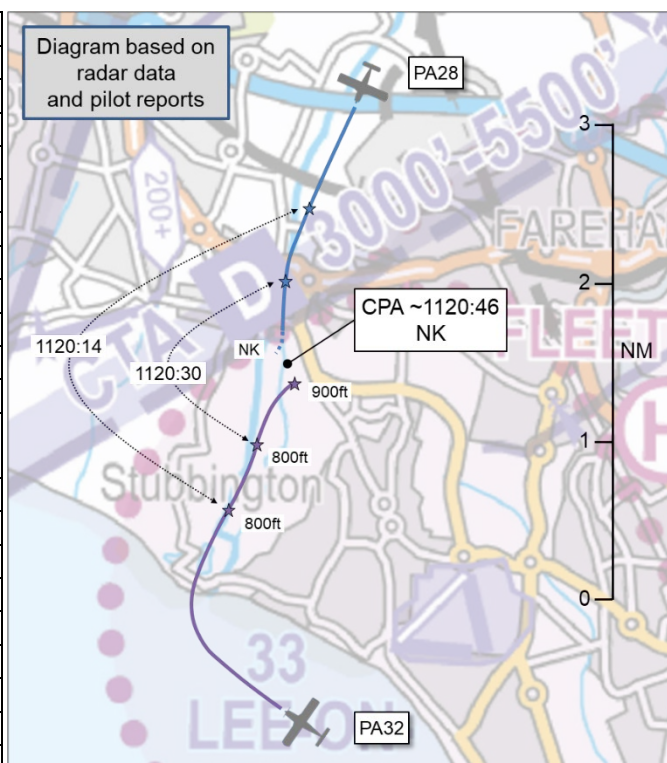
An analysis of the NATS radar replay was undertaken and the PA32 could be positively identified from Mode S data. The PA28 was identified by reference to the reported positions and altitude. No Mode C returns were observed on the replay from the PA28 after 1120:06, and primary returns faded after 1120:38. Neither aircraft was observed by reference to ADS-B data sources.
