**AIRPROX REPORT No 2026048**

Date: 18 Apr 2026 Time: 1223Z Position: 5150N 00107W Location: 7.5NM E Oxford Airport

**PART A: SUMMARY OF INFORMATION REPORTED TO UKAB**

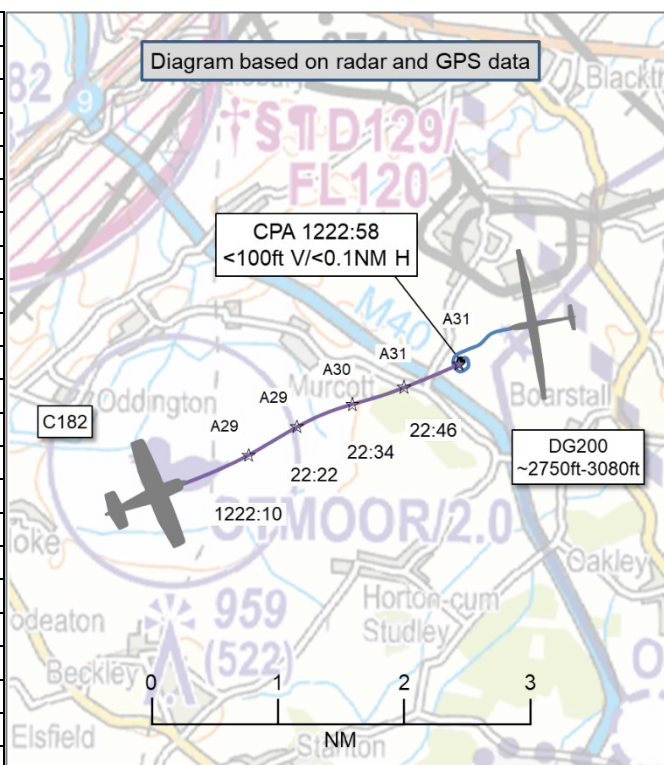
| Recorded | Aircraft 1 | Aircraft 2 |
|---|---|---|
| Reported | 20ft V/100m H | 200ft V/0.5NM H |
| Recorded | <100ft V/<0.1NM H | |
