**AIRPROX REPORT No 2026049**

Date: 19 Apr 2026 Time: 1131Z Position: 5342N 00127W Location: 2NM NE of Wakefield

**PART A: SUMMARY OF INFORMATION REPORTED TO UKAB**

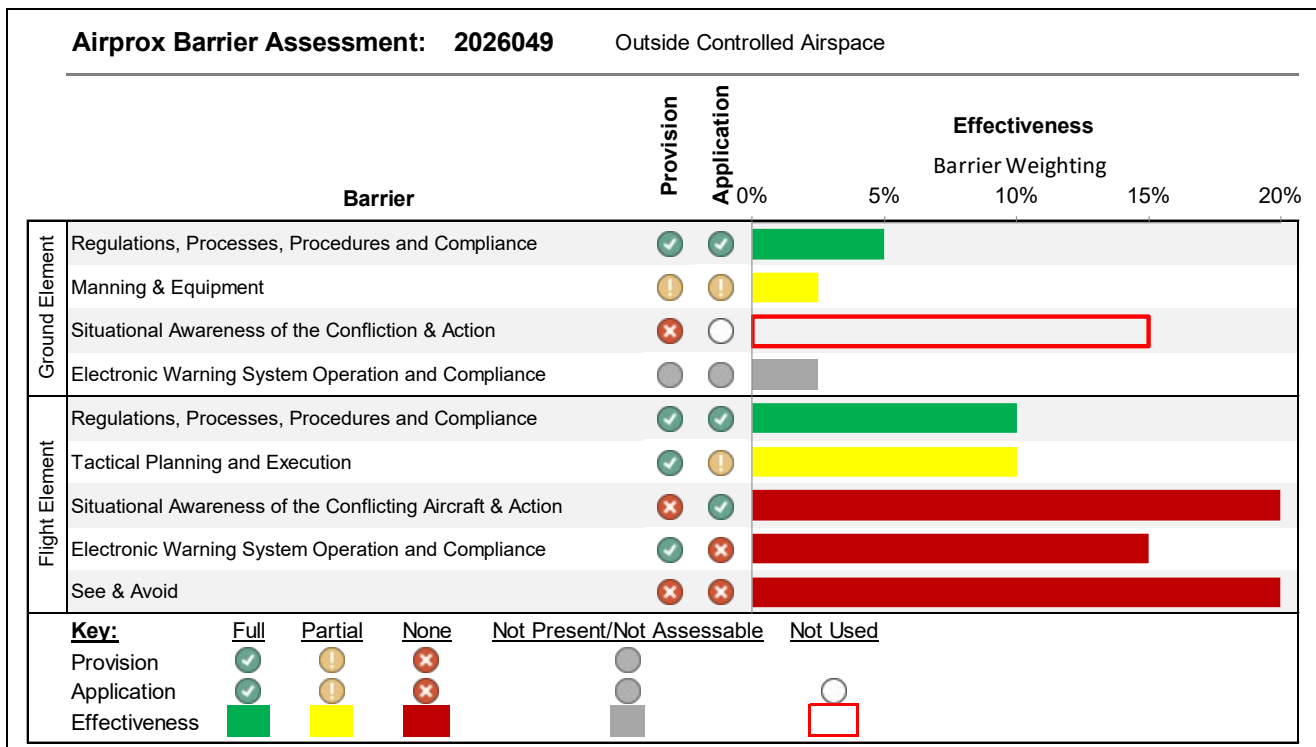
**See and Avoid** were assessed as **ineffective** because the Pioneer pilot had not seen the Sportcruiser and the Sportcruiser pilot had visually acquired the Pioneer only at a very late stage.
