**AIRPROX REPORT No 2026055**

Date: 25 Apr 2026 Time: ~1716Z Position: 5205N 00208W Location: Defford

**PART A: SUMMARY OF INFORMATION REPORTED TO UKAB**

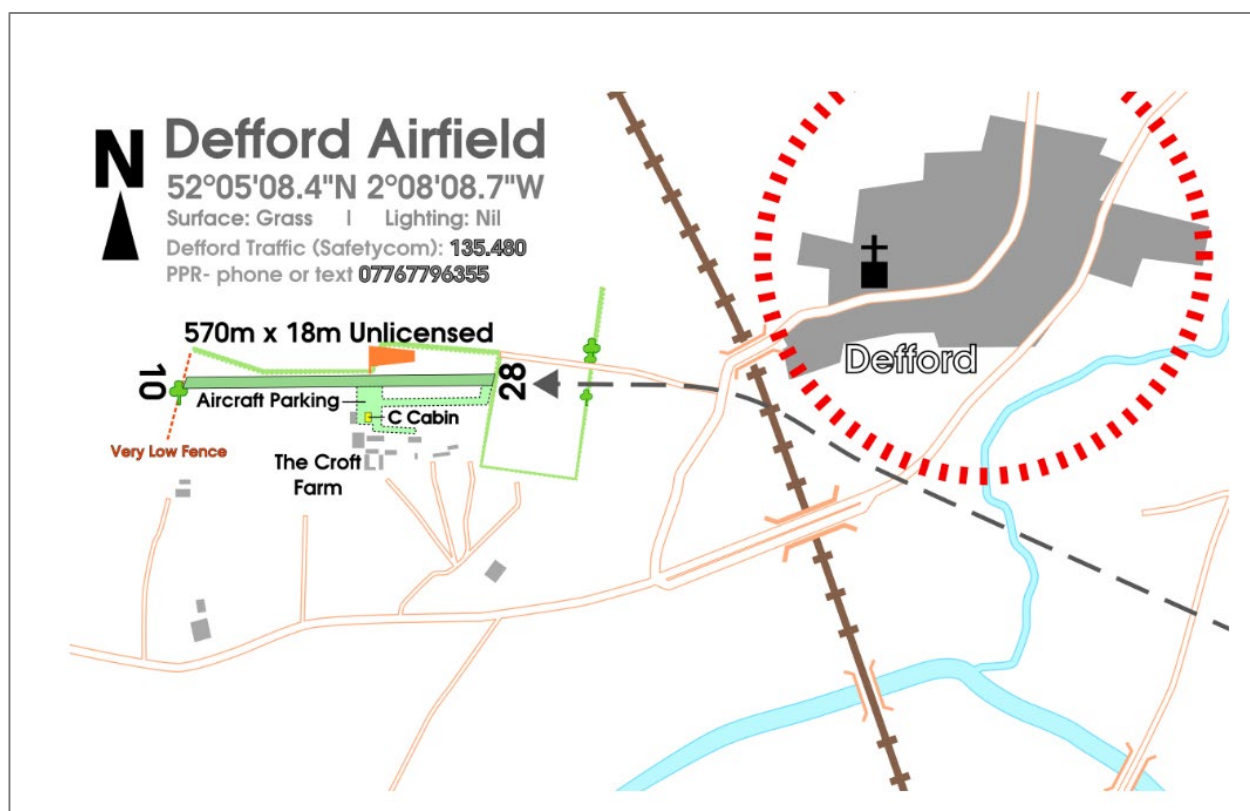
Radio SAFETYCOM - 135.480MHz. SAFETYCOM is a common frequency introduced for use by aircraft in the vicinity of an airfield or landing site that does not have a notified VHF frequency for radio communication. SAFETYCOM is to assist pilots to avoid potential conflict and should only be used to broadcast the pilot's intentions. It is a single common frequency for many landing sites. Therefore it is important that transmissions are concise and correct. Remember to make clear that the reference is to Defford. Transmissions should be below 2000 ft above landing site and within 10 miles radius.

Circuits - All Circuits to be flown to the south. Please make Standard Circuit calls and keep a good lookout for other traffic.

The EV97 was tracked by radar and identified via Mode S data. The D140 did not show on radar. Neither aircraft was displayed on ADS-B/MLAT tracking tools available to the UKAB Secretariat within 3min of CPA.
