**AIRPROX REPORT No 2026056**

Date: 27 Apr 2026 Time: 0951Z Position: 5143N 00135W Location: IVO Brize Norton

**PART A: SUMMARY OF INFORMATION REPORTED TO UKAB**

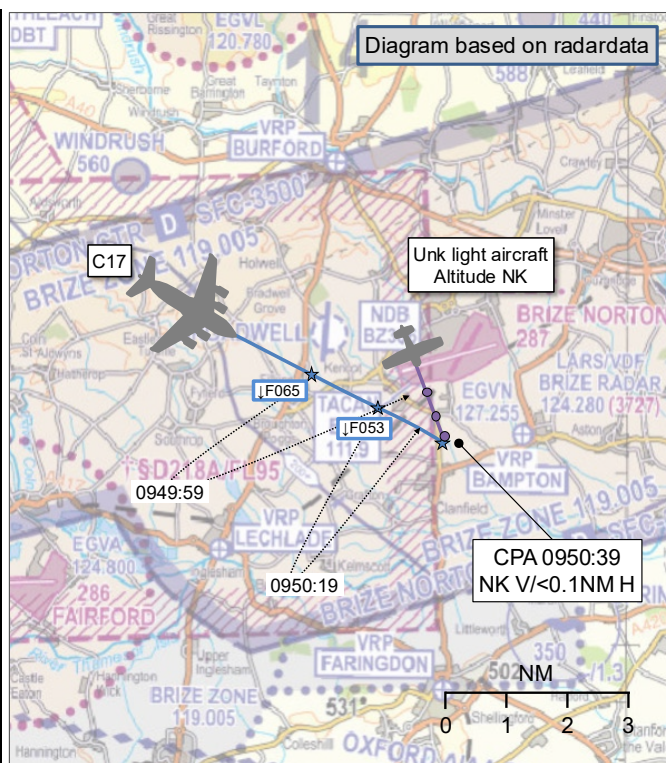
| Recorded | Aircraft 1 | Aircraft 2 |
|---|---|---|
| Reported | 0ft V/100-150m H | NK |
| Recorded | NK V/<0.1NM H | |

**THE C17 PILOT** reports that, during a co-ordinated VMC descent through 4000ft in the overhead of RAF Brize Norton, ATC (Tower Frequency) notified the C17 crew of an intermittent contact in the vicinity of RAF Brize Norton. Shortly after this notification, a high-wing light aircraft was spotted by the C17 crew, in the low 10 o'clock, traveling in the same direction on a slightly converging heading. The C17 descent and speed differential was increasing separation by the time a flightpath adjustment could be made. The closing speed of the C17 was assessed as in excess of 100kt and it was considered unlikely that the pilot in the light aircraft would have seen the C17 due to the high wing configuration of the light aircraft. The GA traffic was considered by the C17 crew to be close enough (approximately 100-150m) to require an Airprox report, and the crew was concerned that the light aircraft could have been adversely affected by wake turbulence. The light aircraft did not appear on TCAS, and no TCAS TA/RA alerts were displayed to the C17 pilots. The light aircraft pilot did not make themselves known on the Brize Tower frequency. The pilot noted that the Pilot Flying (PF) was on the side of the cockpit nearest the contact, however, the PF was glancing at their TCAS display to see if the intermittent contact notified by ATC was depicted (it was not). The aircraft was spotted cross-cockpit by the Pilot Monitoring.
