**AIRPROX REPORT No 2026069**

Date: 09 May 2026 Time: 1308Z Position: 5144N 00007E Location: IVO North Weald

**PART A: SUMMARY OF INFORMATION REPORTED TO UKAB**

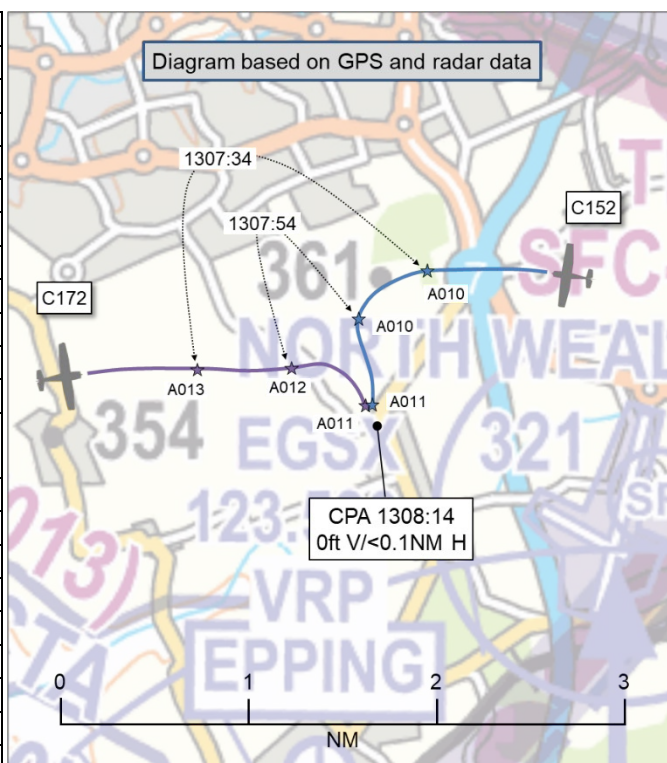
An analysis of the NATS radar replay was undertaken and both aircraft could be positively identified from Mode S data (Figure 1). The C152, but not the C172, was observed by reference to ADS-B data sources. The pilot of the C172 kindly supplied GPS track data for their flight. The diagram was constructed and the separation at CPA determined by combining the data sources.
