**AIRPROX REPORT No 2026070**

Date: 01 May 2026 Time: 1554Z Position: 5143N 00053W Location: Bledlow

**PART A: SUMMARY OF INFORMATION REPORTED TO UKAB**

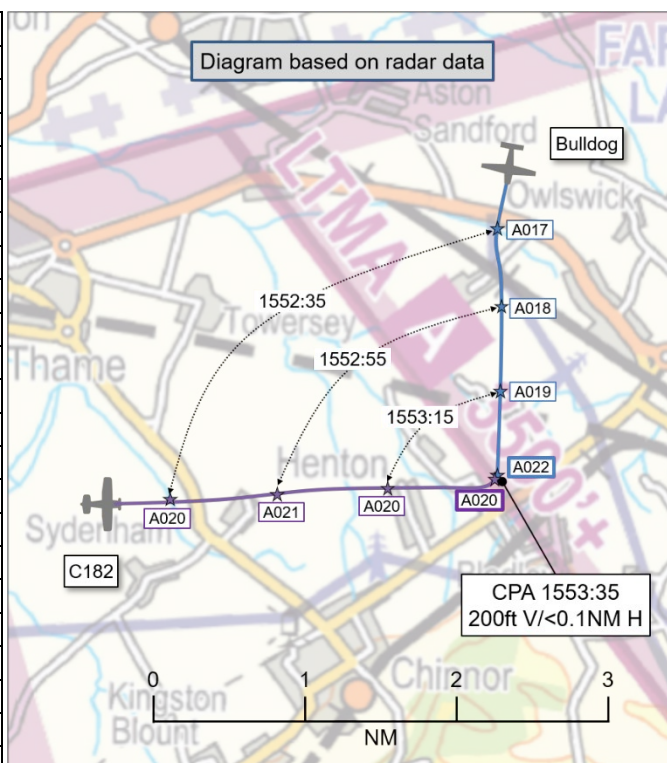
**THE BULLDOG PILOT** reports that they were travelling with a very experienced pilot in the right-hand seat, and they were flying back from [destination] late in the afternoon. [The weather] was CAVOK and conditions for flying were perfect. This naturally meant that airspace was busy, even in the more remote parts of the track. The aircraft was being flown with electronic conspicuity (EC) software being displayed on a large tablet and, in addition to ADS-B traffic, it was displaying [common glider EC] traffic. On the outbound journey, they also used a mix of Basic Service, listening squawks, and London Info. They discussed the merits of a Basic Service compared to listening squawks, their passenger favouring the latter as a Basic Service gives the ATCO no obligation to give any warning of traffic. The pilot preferred taking any service. This was to become a very prophetic discussion. On the return journey, after talking to a succession of ATSUs and trying to talk to many that were closed, they settled on talking to London Information on 124.750MHz. Around ten or so miles north of Stokenchurch mast, they elected to talk to Farnborough West on 125.250MHz and got a Basic Service. Travelling south at somewhere between 1700ft and 1900ft and near Stokenchurch mast, around about 1600, they received an urgent transmission from the ATCO, cautioning them of imminent conflict traffic at about one o'clock, travelling right-to-left. Nothing seen, they leaned forward in the seat to see a white, high wing GA aircraft behind the frame of their canopy, slightly lower and to the right. It was very close. They immediately pulled up and to the right to avoid and, on landing, they saw that their G meter had registered 2.5G in that pull up. Nothing had registered on their EC device. [They believed that] the [pilot of the] other aircraft never saw them.

The pilot further noted that they were flying straight and level [they thought] and that the other aircraft was 100m away on first sighting and below. They reported that the windshield frame had occluded the traffic initially and, for the other aircraft, that the high wing had probably blocked their view of the Bulldog.

The pilot assessed the risk of collision as 'High'.

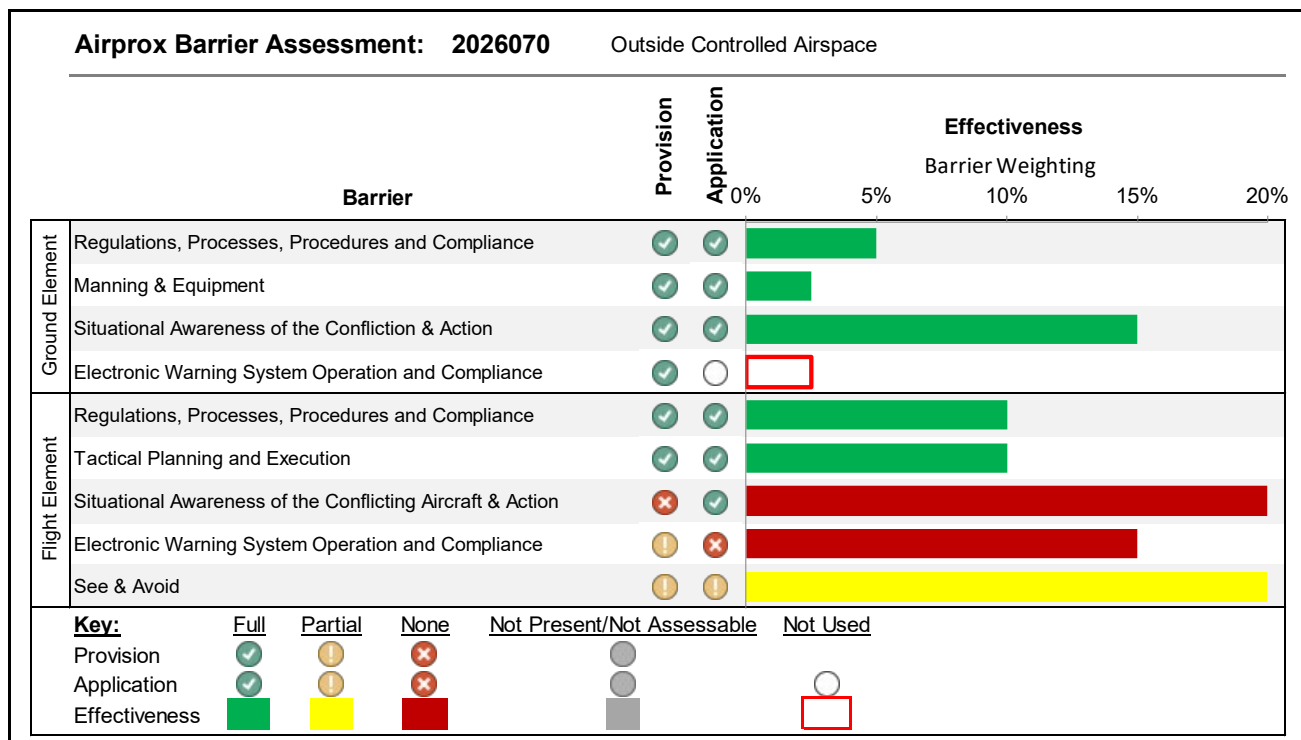
**Electronic Warning System Operation and Compliance** were assessed as **ineffective** because the Bulldog's electronic conspicuity (EC) equipment was unable to detect the C182, and the C182 pilot had not reported having received an alert from their EC device when it might have been expected.

**See and Avoid** were assessed as **partially effective** because both pilots had sighted the other aircraft at a late stage.
